# Robustness: The quality Ribera missed in 1905

## *Robustez estructural: la calidad que echó de menos Ribera en 1905*

Eduardo Díaz-Pavón Cuaresma<sup>a,\*</sup>, Javier León González<sup>b</sup>, Jorge Ley Urzáiz<sup>a</sup>

This is also the case of the collapse of the roof of the Third Reservoir of Canal de Isabel II in Madrid in April 1905 [4]. This is an excellent example of a projected structure lacking analysis of robustness. 30 people died and 6 people were injured in this accident, which is one of the most serious to happen in building in Spain and yet is still little known. The following section will look at this case to analyze its cause and subsequently reflect on the subject of robustness in existing structures.

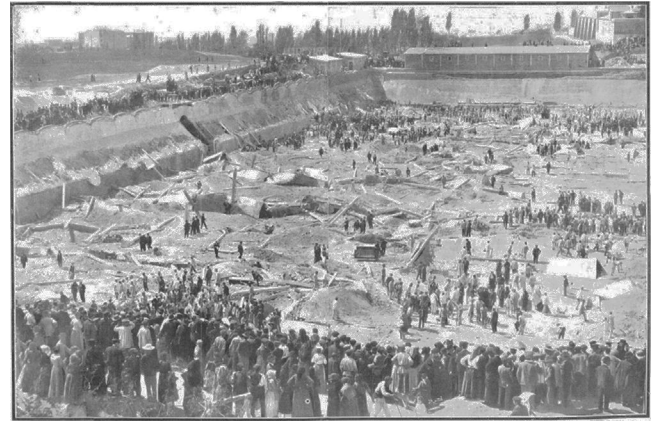
The construction of the roof was carried out at the same time as the four chambers in which the reservoir was divided. The works began on the 4th chamber which was located to the south in spring 1904. In April 1905, this 4th chamber was practically covered, whilst in chambers 1 and 2, the columns and the main girders had been placed and the placement of the vaults was beginning. Between the 5th and 6th of April, a series of load tests were carried out, consisting of placing an 80 cm layer of soil along the length of one strip of vaults. The soil was taken from the adjacent vaults hence leaving them without soil cover. The following day, 7th April, the works of distributing the soil over the vaults continued. On the 8th, early in the morning, the collapse happened (Fig. 3).

Figure 3. General view of the disaster area (*Nuevo Mundo*, April 1905).

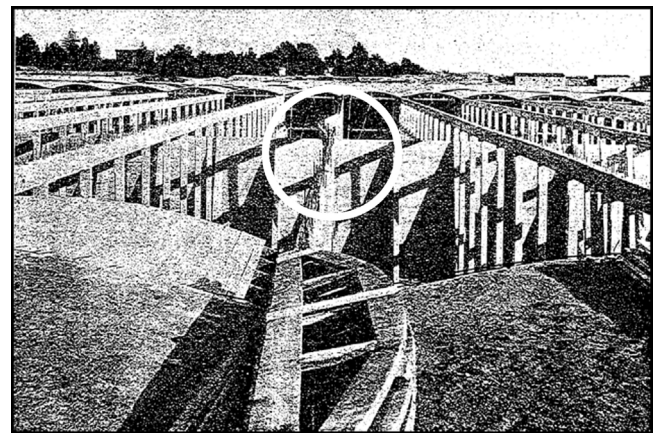
Figure 7. Deformations of a beam in the first chamber, June 1905. *Revista de Obras Públicas*, 14 March 1907.

A determinant factor in Ribera's acquittal was the deformation observed in a number of beams in the first and second chambers at the beginning of June, just two months after the collapse (Fig. 7). These gave rise to numerous articles and opinions attributing the failure of the vaults, to a certain degree, to have been caused by the high temperatures suffered in the month of April. In fact, surprising as it may seem (it is to be taken into account the collapse occurred at 7 o'clock in the morning) most of the existing bibliography to this respect has this hypothesis as the main cause of the collapse. Regarding the real effect

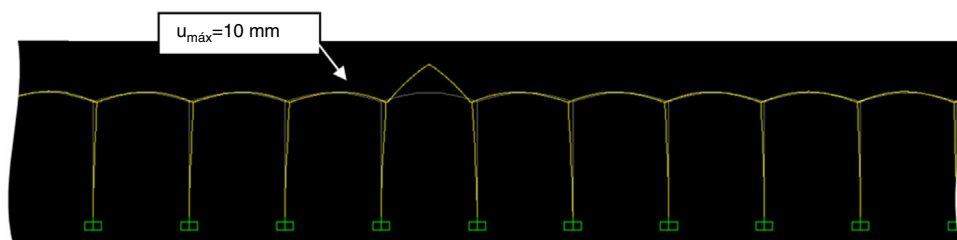
In this sense, Fig. 8 shows the deformation of the transversal section of the vaults assuming that the crown of the central one were the neutral point for horizontal displacements and, simultaneously, a three-hinge arch was formed. This hypothesis would be coherent with the deformation scheme presented by the

Figure 8. Deformation of the vaults supposing rotation in the central area (for reasons of clarity, only the 10 central vaults are shown of the existing 36 spans).

The magnitude of the displacements shown in the deformed shape brings to light the minor effects this local discontinuity produced upon the rest of the transversal section of the roof structure. This fact is confirmed if the internal forces are analyzed, showing that they are very low and far from those which would lead to failure of the springing of the arch, which is the weakest in the case of the roof [4]. Once again, stability is guaranteed.

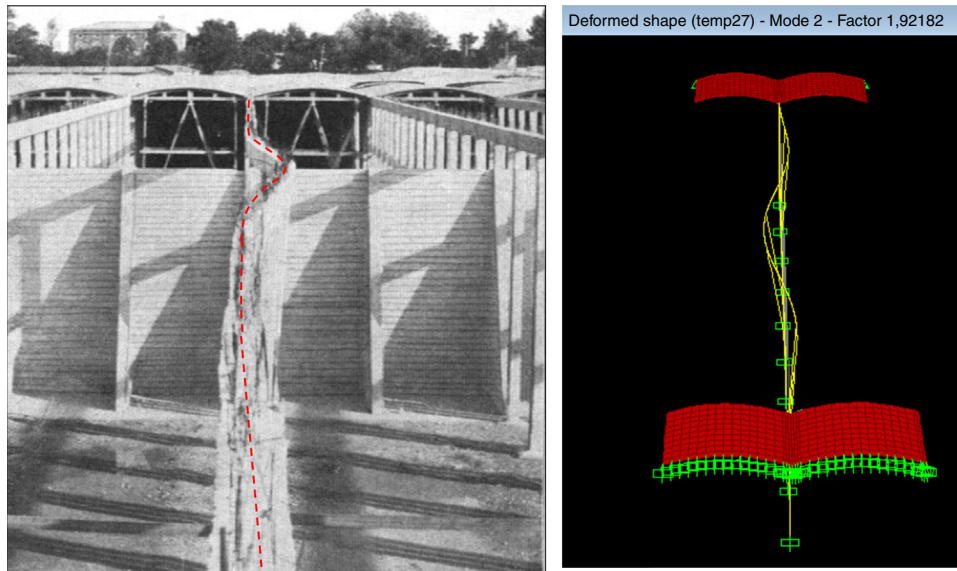
Figure 10. Observe the similarity between one of the failure modes found and the instabilities in the first and second chambers.

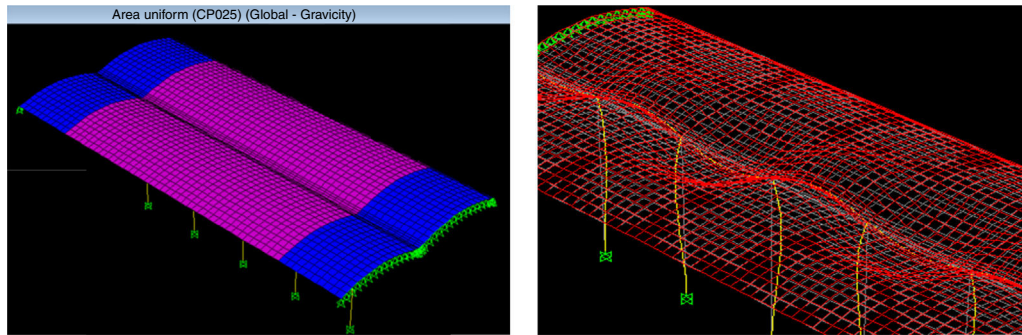
Even taking into consideration the thermal increase, the ratio between the theoretical critical axial load of these beams and the load due to thermal increase is in the order of 142 as is shown in Fig. 11. Moreover, the first six modes of buckling detected by the model are found in the plane of the portal frame and not orthogonally which hence lays bare the enormous contribution the vaults have in stabilizing the beams.

Figure 11. Buckling mode of finished roof. Instability is discarded in the plane of the vaults.

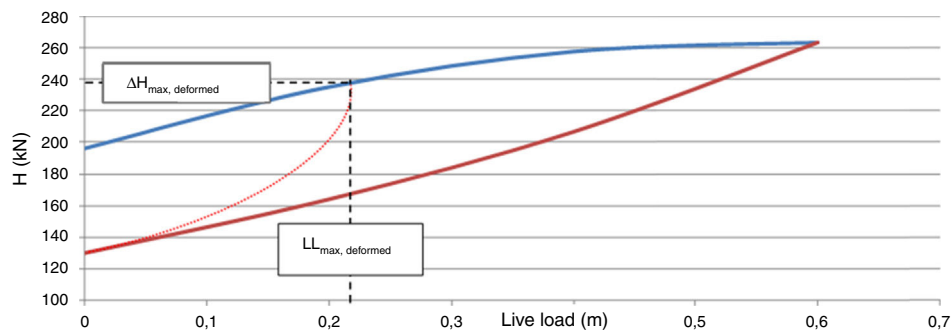
Figure 12. Reactions in the support corresponding to the lines of pressure of maximum (upper curve) and minimum thrust (lower curve), in the case of uniformly distributed 25 cm deep soils and live-load (LL) on haunches. The discontinuous line graphically represents the thrust when a displacement of the support occurs.

This sensitivity regarding asymmetric actions is complex to evaluate. The asymmetric load provokes a displacement in the support (a shift away from) which would cause the vault, which mobilizes initially the line of minimal thrust, would continue to increase such thrust as the displacement increases (greater span, less rise, more thrust: the discontinuous line in Fig. 12). The evolution of thrust and shift is clearly non-linear and therefore difficult to foresee. The deformation of the arch depends on the stiffness of the structure as a whole and such stiffness depends on the loads, whose increase could cause the relaxation of the structure (by cracking) so making the deformations ever greater.

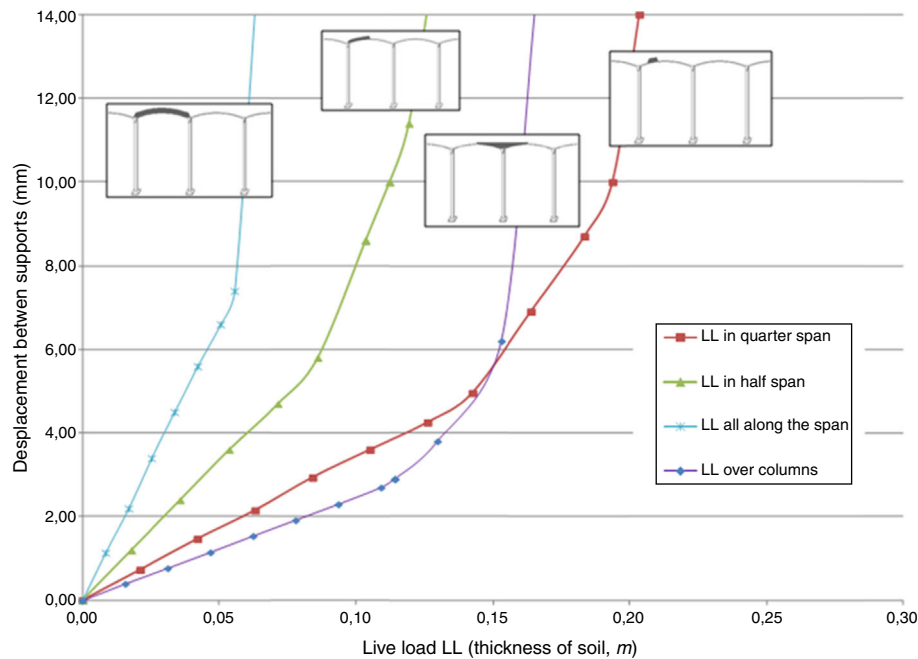
As may be appreciated in all cases, in reduced differences of loads, the behaviour is clearly elastic and the displacement between supports is very small. However, when the vaults begin to crack the flexibility increases greatly and the displacements shoot up, increasing at an uncontrolled rate for very low increases in load. In this way, the point where the roof collapses is reached, which in any case is caused by the loss of shape of the loaded vault (snap-through failure mode). Failure caused by instability of a column was discarded.

Akin results are obtained for the roof without soils (beyond non-uniform loads). For example, if the load accumulates asymmetrically along half span, the flexibility of the roof is very pronounced as from 10 cm, reaching point of collapse at less than 15 cm.

Figure 13. Effects of excess asymmetric loads upon the roof with 25 cm of soil.

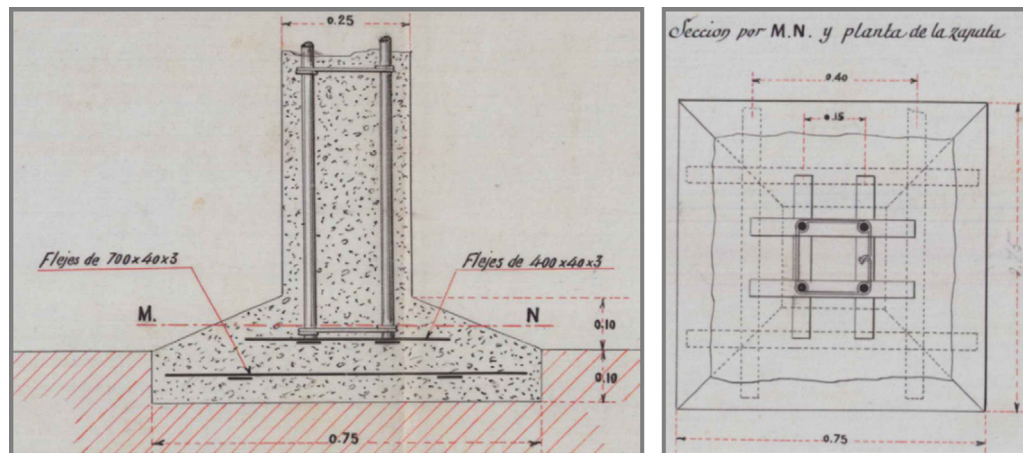
There is one single aspect which, in the stated nominal situation would not have had any initial importance, but could have influenced in the extension of the failure to the whole roof once started, and even favoured the initiation of said failure, as shall be commented on in the following points. It addresses the detail of the footings of the columns over the foundations (Fig. 14). Apparently inherited from the tradition of masonry and steel, the

Figure 14. Detail of column footing on the foundation.

reinforcement of the columns starts above the foundations, without ensuring the anchorage to it, and therefore without offering the section of the column footing the capacity of bending (further than this being a mass concrete element, that is, what is due to the eccentricity of the axial loads in respect to the column's axis, which is very reduced due to its outstanding slenderness).

As a final example, and getting back to the Third Reservoir, we can return to the footing detail of the columns on the foundations. The configuration shown in Fig. 14 is not exclusive to Ribera, being equivalent of that used, for example, by Hennebique or which may be found in some of the first publications on reinforced concrete of the time (Fig. 20).

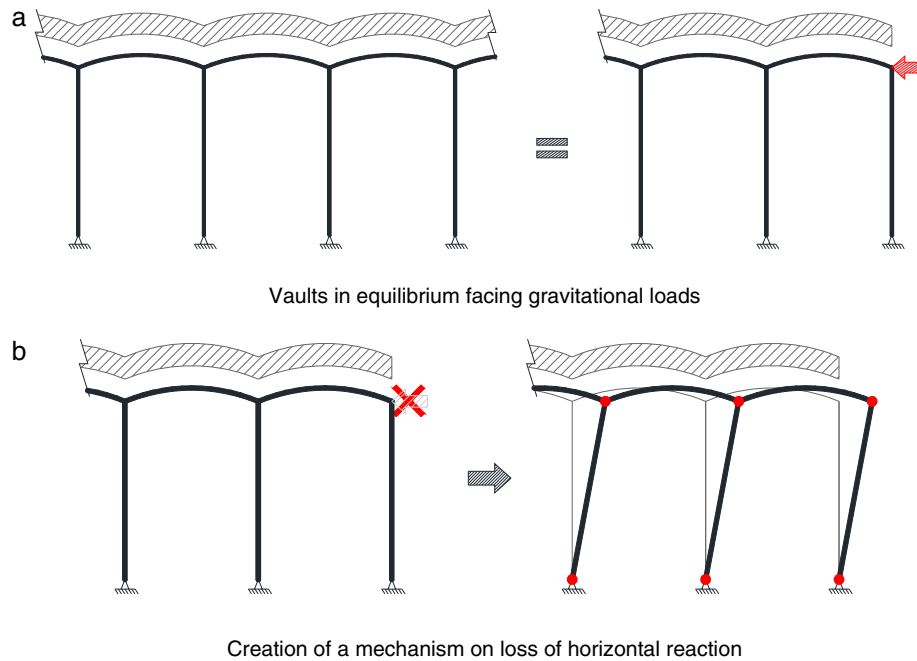
As has just been explained, the investigation which was carried out concluded that the severity of the accident in the 4th chamber of the Third Reservoir was due to an extremely sensitive configuration of the structure when faced with any local failure which, once begun, would cause this failure to extend to the rest of the roof (Fig. 15).

Figure 15. Resistance model of Third Reservoir.

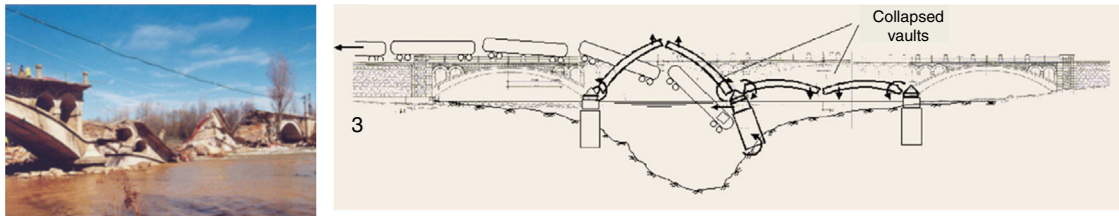
around the piers so provoking slight rotations of the foundation and the consequential failure of a span and hence the failure of the remaining spans.

Figure 19. Graph showing the formation of a collapse mechanism due to pier rotation in the Veguellina de Órbigo bridge, León (constructed in the early 1930s).
