## **Occurrence of landslides during the approach of tropical cyclone Juliette (2001) to Baja California Sur, Mexico**

The approach of tropical cyclone (TC) Juliette, in 2001, to the Baja California Peninsula triggered at least 419 landslides. Most of the landslides were shallow slips and debris slides of limited areal extent, which were converted rapidly into debris flows to be exported quickly out of the mountain areas towards the lowlands. Main factors affecting landslide occurrence were total storm rainfall and intensity, aspect, geology and vegetation association. Two processes can be distinguished as initiating slope failure. Accumulation of rainfall from exposed bedrock slopes, generating excess overland flow, was the main process linked to failures in

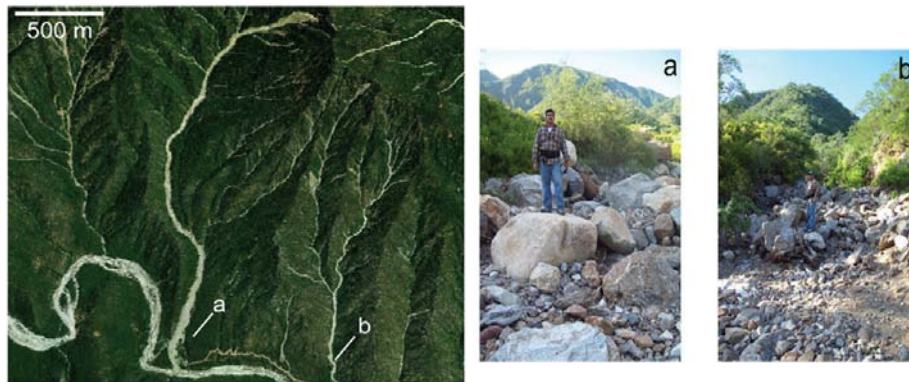
Fig. 6. Debris flow deposit remains on two channels in the Portezuelo-Ancón Grande catchment. Main panel shows extent of the landslides in this area. Main channel bed elevation ranges from 460 m in the left to 360 m at the lower right portion of the image. Highest ridges at the top of the image display elevations of ~1200 m. Note other shallow slips and debris flows paths originating from the ridges in the upper portions of the image. Date of GeoEye® imagery: 2005. (a-b) Ground views of the lower portions of the debris flows paths shown in the image. Mostly metamorphic rock boulders (1-2 m in diameter) remain in the streambed, and finer grain size sediment has been stripped. Date of ground photographs: 2011.

*A. Overland flow triggered debris flows and shallow slips.* For an important portion of the landslides, failures occurred immediately below areas of exposed bedrock, in the upper third of the slopes. The corresponding mechanism appears to be related to generation of excess overland flow impacting semiconsolidated colluvium, as reported in other semiarid mountain settings (e.g., Griffiths *et al.*, 2004; Webb *et al.*, 2008; Coe *et al.*, 2008). Although the SLL displays more vegetation, including arboreal species not present in the regions above described, concentration of runoff at the end of upper slope ravels or at the foot of bedrock cliffs had probably the same “fire hose” effect (e.g., Johnson and Rodine, 1984) described in those regions. This mechanism requires streamflow over a waterfall on preexisting colluvial wedges at the base of cliffs, causing failure and subsequent mixing to create a slurry (*cf.* Griffiths *et al.*, 2004). Relatively scarce understory cover in the tropical dry and oak forests in these catchments (León-de la Luz and Breceda, 2006) might be responsible for this effect. Once the initial portions of the surface sediment are mobilized, they displace downslope, either eroding and incorporating more sediment into a debris flow, or entering into a first or second order channel. The sediments may be later removed by action of a subsequent debris or channel flow. Our field observations indicate that this removal may be strongly dependent on the original triggering mechanism. If overland flow was involved, as hypothesized for the debris flows in the San Lázaro catchment, streambeds tend to remain free of sediment. In other cases, large boulders are left as a lag deposit (Fig. 6).

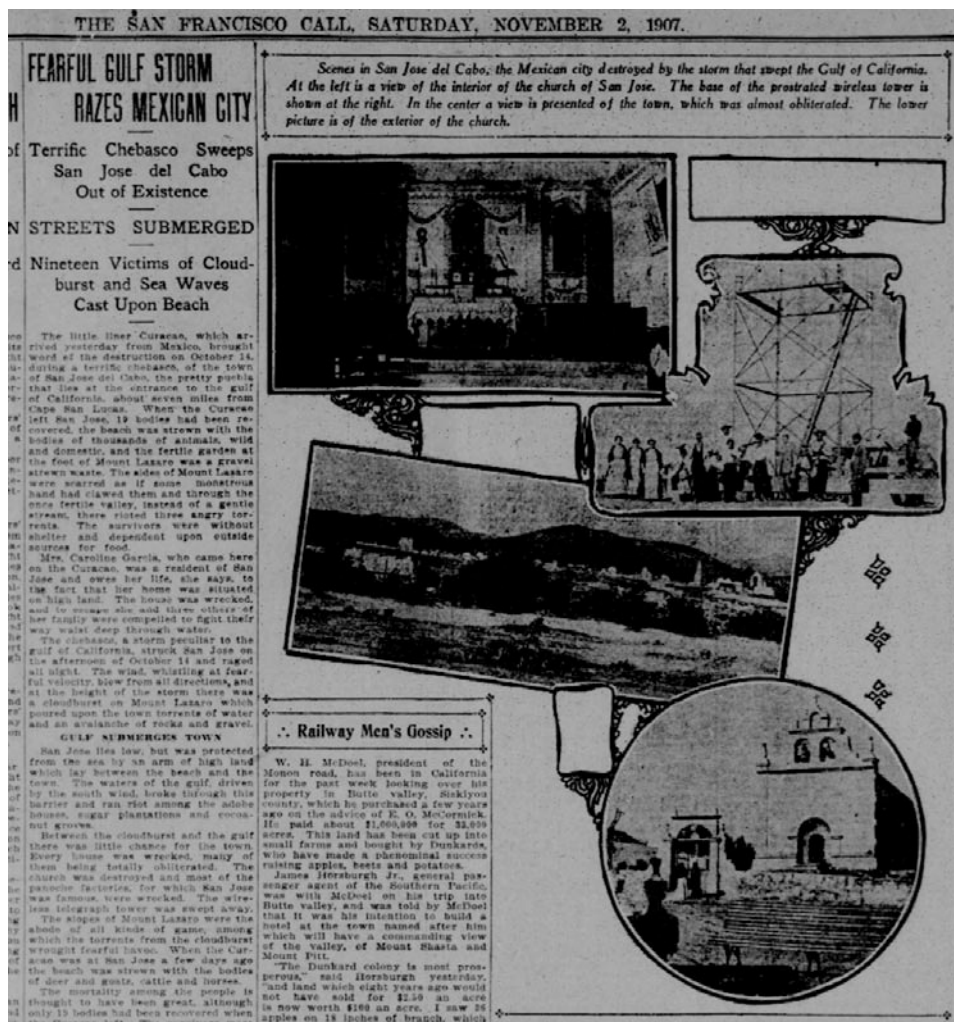
Fig. 15. Clipping from the *San Francisco Call*, Saturday, November 2, 1907, depicting the damage of a tropical cyclone affecting San José del Cabo and neighboring regions on October 14, 1907. Available at the Online Archive of California: <http://www.oac.cdlib.org/> [last accessed 2011/10/10].

Reports on the October 1907 event display also other interesting observations: “The [...] liner Curacao [...] brought word of the destruction on October 14, during a terrific chebasco [*sic*], of the town of San José del Cabo [...] The fertile plain [San José river?] that had yielded several thousand people a comfortable living, had been robbed of its soil by the torrents which had left instead a barren pile of gravel and rocks” (*San Francisco Call*, November 2, 1907, p. 9). Observations from the effects of Juliette are very similar. However, the damage in 2001 appeared to be more contained and restricted to the riverbed and the lower terraces, and it is likely that the effects of the 1907 event were indeed larger than the ones associated with Juliette. In the early 20th century, after destruction of the old town of San José in 1895 by the effects of another TC (Antinao and McDonald, 2011), the main government buildings had already been relocated to a place closer to their current location; therefore, the larger effects observed in the 1907 flooding would imply a larger flood than in 2001.
