# Structural refurbishment strategies on industrial heritage buildings in Madrid: Recent examples

## *Estrategias de intervención estructural sobre edificios del patrimonio histórico industrial de Madrid: realizaciones recientes*

Juan Rey Rey<sup>a</sup>, Pablo Vegas González<sup>b</sup>, Jacinto Ruiz Carmona<sup>c,\*</sup>

This paper discusses some common strategies applied to structural intervention on several buildings in which this task has been developed by Mecanismo Structural Engineering.

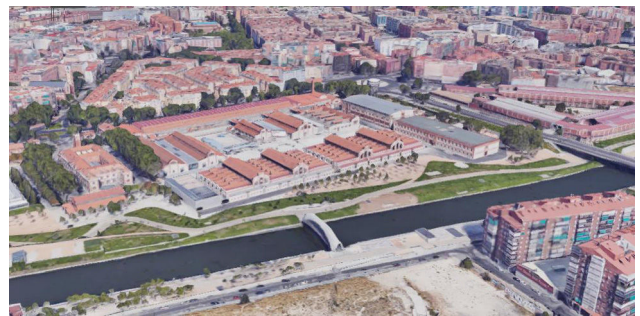
Figure 2. Current aerial view of Matadero de Madrid complex.

The old slaughterhouse in the neighborhood of Legazpi, by the Manzanares river, was designed by architect Luis Bellido. It consists of a series of warehouses built between 1908 and 1928 out of masonry walls and both steel and reinforced concrete (some of the first in the city of Madrid) structures [1] (Figs. 1 and 2).

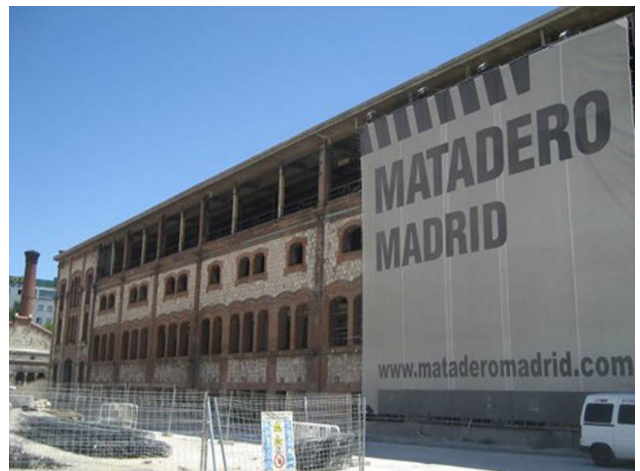
Figure 3. Warehouse 8. Outside view.

Warehouses 8 and 9 are the biggest of the whole complex ( $70 \times 34$  and  $94 \times 24$  m, respectively); their structures combine reinforced concrete slabs, columns and beams, and masonry perimeter walls. As a starting point for designing the intervention project, we had a report on “Materials inspection and characterization” by CEDEX [4] and a “Study on Foundation Characterization” by LCC [5], as well as the compulsory geotechnical study [6] (Figs. 3 and 4).

The concrete structure presented a poor conservation status: apart from its low compression strength capacity (estimated characteristic strength was 5–10 N/mm<sup>2</sup>), the main pathology was the general reinforcement corrosion. As a result of the aforementioned, it was not advisable to use the existing concrete structure elements for supporting the overloads derived from the new intended purposes.

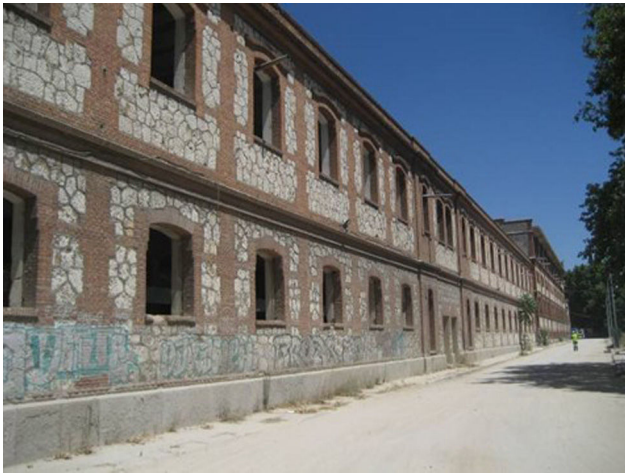
Figure 4. Warehouse 9. Outside view.

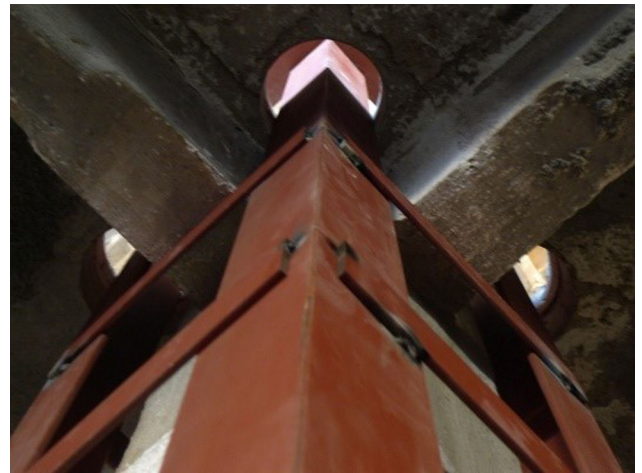
Figure 6. Already executed columns passing through the slabs.

Furthermore, the architectonic guiding principle was to make it possible for both old and new structures to coexist in the same space without eliminating each other. The visual power of the concrete structure, one of the first ever built in Spain, should not be altered by the new steel structure. In order to achieve this independence, the final decision was to separate them clearly (Figs. 5 and 6).

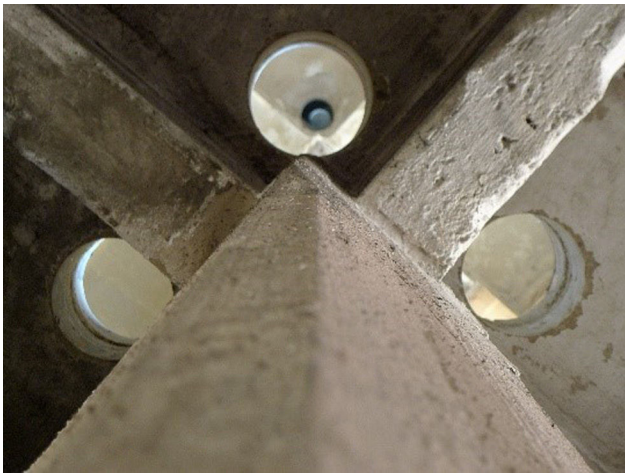
Figure 5. Space for new columns through existing slabs.

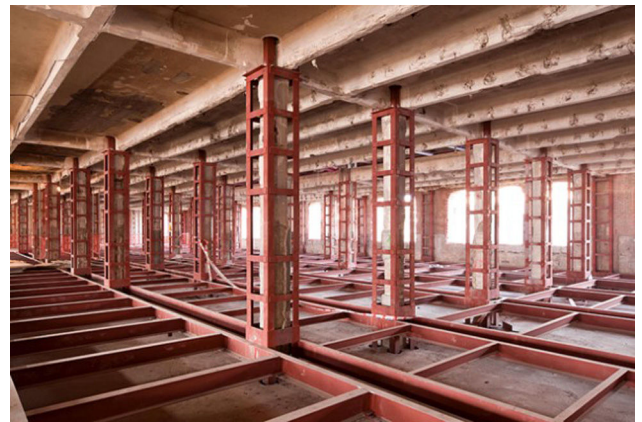
Figure 7. New steel structure in warehouse 8.

Thus, it was proposed to build a new steel structure inside the existing one that would support all new loads, also laying the slabs on the existing floors and leaving the foreground to the original exposed concrete ceilings. Therefore, the new steel structure was dimensioned in order to support one hundred percent of the expected loads resulting from the new purposes, so the existing structure would not have a supporting role

(except for the need of supporting itself). This proved to be feasible once the damages on the structure were repaired (Figs. 7 and 8).

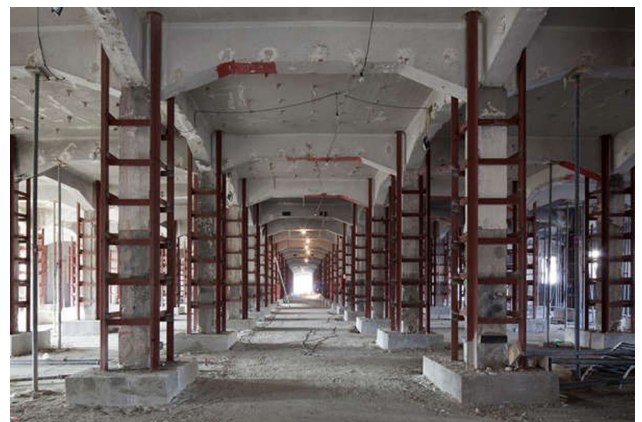
Figure 8. New steel structure in warehouse 9.

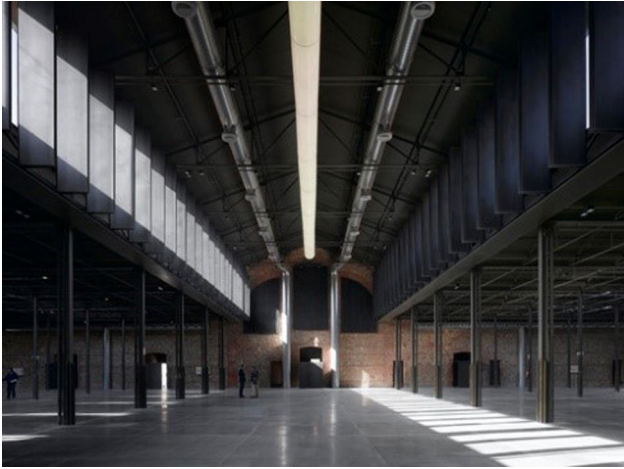
Figure 12. Inside view of the refurbished steel structure in warehouse 16.

As for warehouse 16, the indoor space was reshaped with a series of big swinging shuttles and doors. In order to achieve this, we had to design a number of steel substructures [9] (Figs. 11–13).

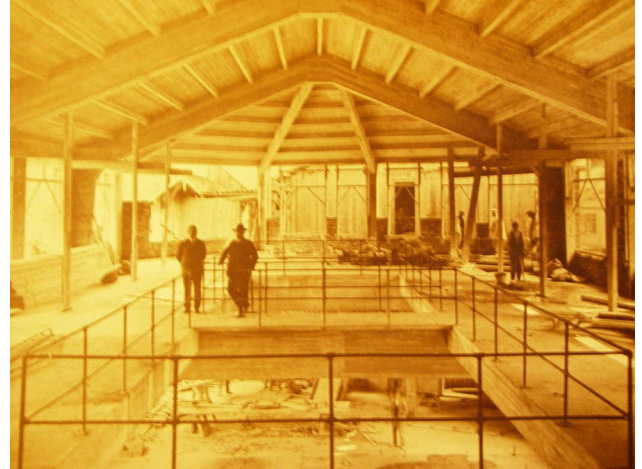
Figure 15. Inside view of the original Serrería.

In order to work on the construction documents, we had access to an evaluation report on the existing structure by Geocisa, which concluded in the need of a structural strengthening for a significant share of the main elements. Given the great historical and esthetical value of the structure, both the architects – authors of the project – and the Madrid City Council technicians desired to keep the original structure untouched whenever possible (Figs. 15 and 16).

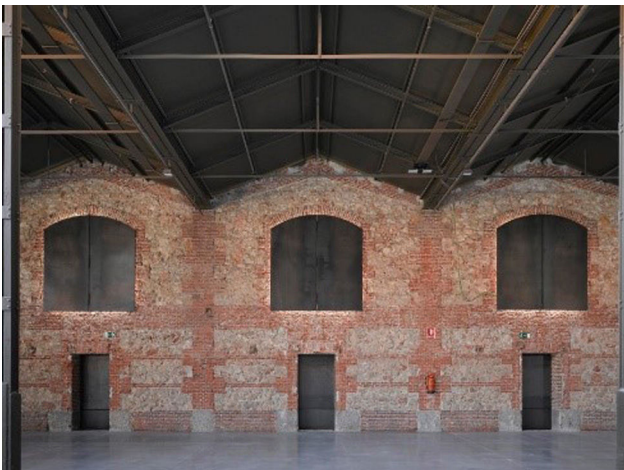
Figure 13. Inside view of the refurbished masonry structure in warehouse 16.

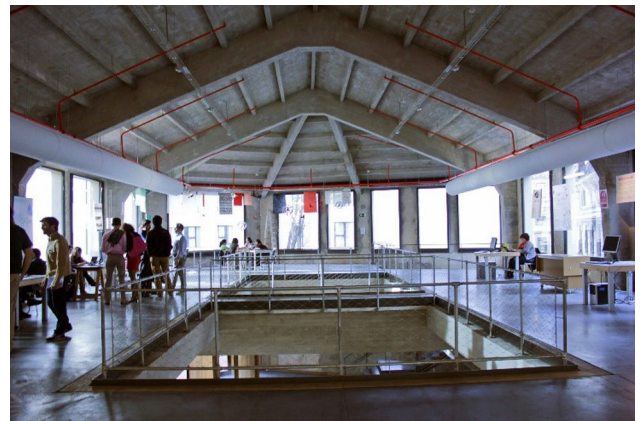
Figure 16. Inside view of the current Serrería.

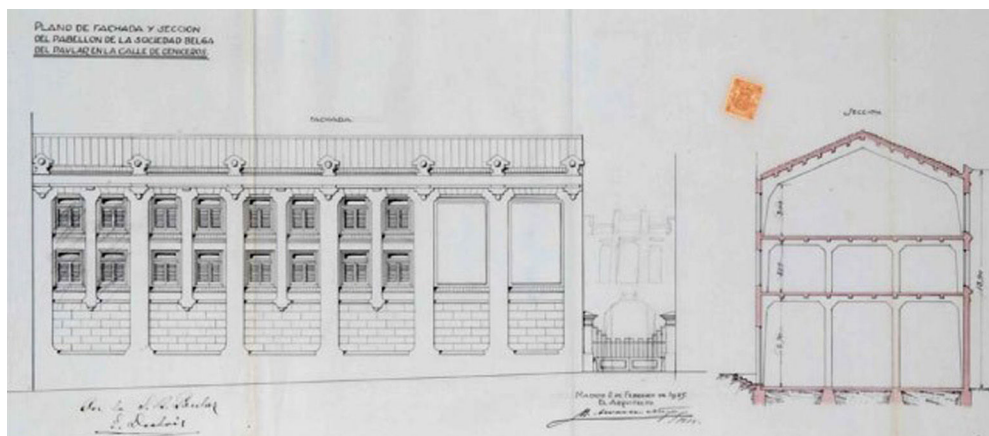
Figure 14. Original drawings by architect Manuel Álvarez Naya (1925). All structure elements—columns, beams, joists and slabs—are visible in the section.

The old Serrería Belga (Belgian sawmill) is a reinforced concrete building designed over the decade of 1920 by architect Manuel Álvarez Naya and is also one of the first to use this material in the city of Madrid [10]. After a long period of neglect, refurbishment works set off in 2007 in order to turn it into the new art creation center Intermediae-Prado [11]. The project has been awarded several prizes amongst which we could highlight 2013 COAM award (Fig. 14).

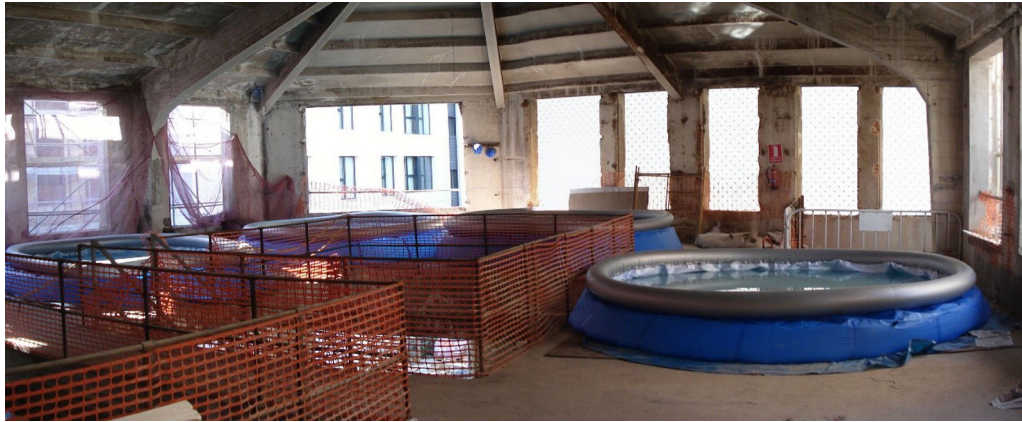
Figure 17. Water containers used for the load test.

Due to the existence of two reports drawing conflicting conclusions, Madrid City Council technicians proposed to do a load test. This load test was planned to assess the structural capacity and followed the requirements established in the EHE

regulations in loads at the time the project was developed. The test results verified the correct behavior of the structure and the structural strengthening of the existing structure could be finally avoided (Fig. 17).

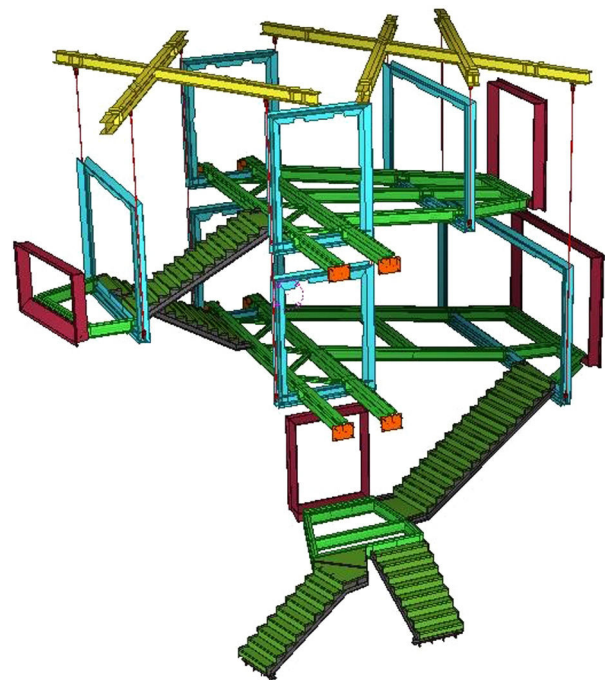
Figure 18. View of the Tekla model developed for fabricating the steel structure.

Once again, the new structure elements were designed with a visibly contemporary language in order to distinct them from the old ones [13]: in this case, it was proposed to set a new communication core in the area occupied by a hall subsequently added to the original structure and which the design project planned to demolish. This new core was planned featuring a steel structure hanging from new trusses supported on four new Y-shaped columns [14]. Closures are stretched textiles. Given the geometric complexity of the steel structure, a Tekla model was developed for creating the shop drawings and fabricating the structure on CAD/CAM (Figs. 18–21).

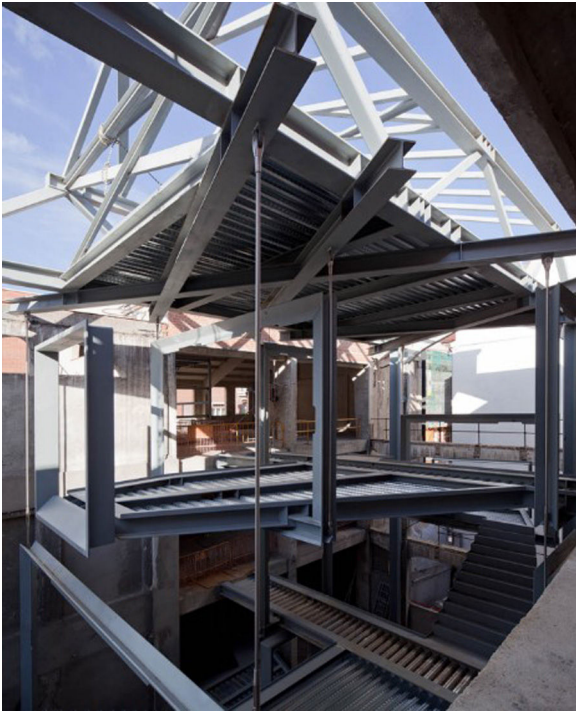
Figure 19. Overview of the structure during the construction process.

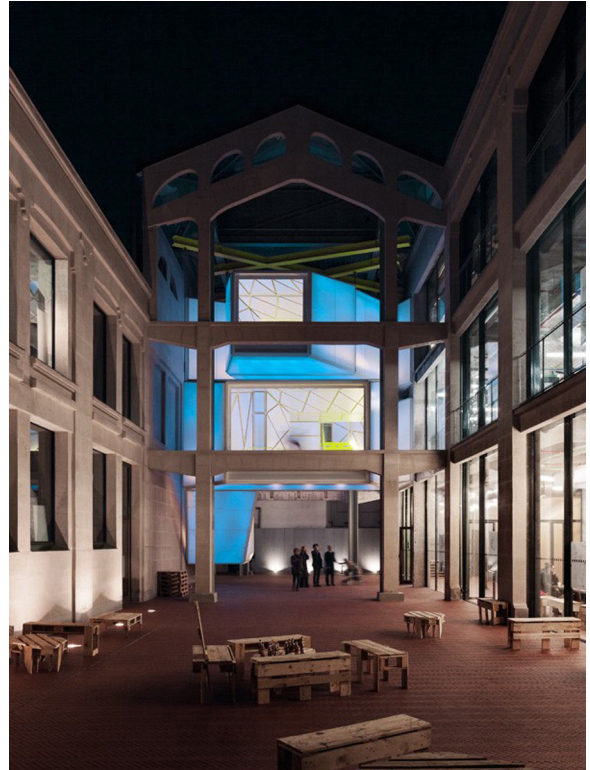
Figure 21. View of both the new steel structure and the original concrete warehouses.

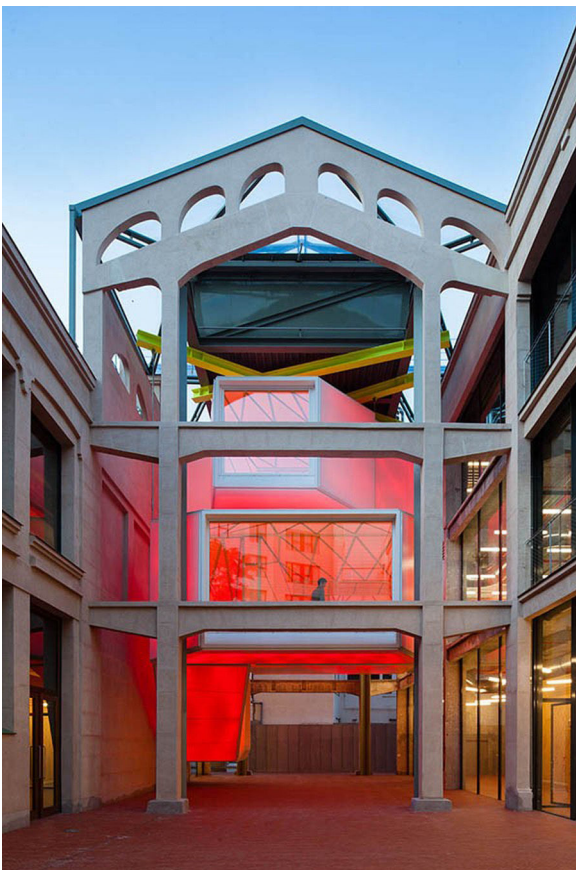
Figure 20. View of the new steel structure from the courtyard.

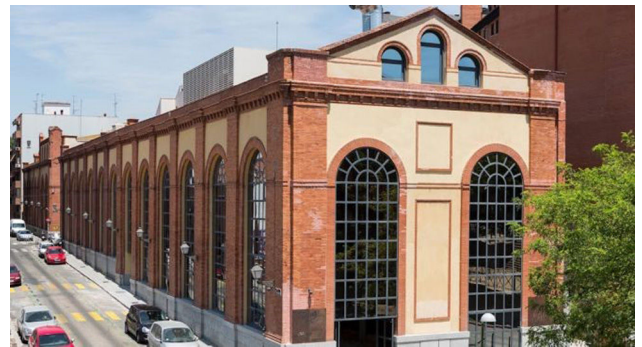
Figure 22. Outside view of the building.

The 1892 building was an open-plan warehouse with a structure featuring masonry perimeter walls and steel trusses in the roof. In a subsequent intervention, it had been refurbished as an office building, and they had then deployed a new bay with steel columns and different new steel slabs levels supported on new steel beams (Fig. 22).

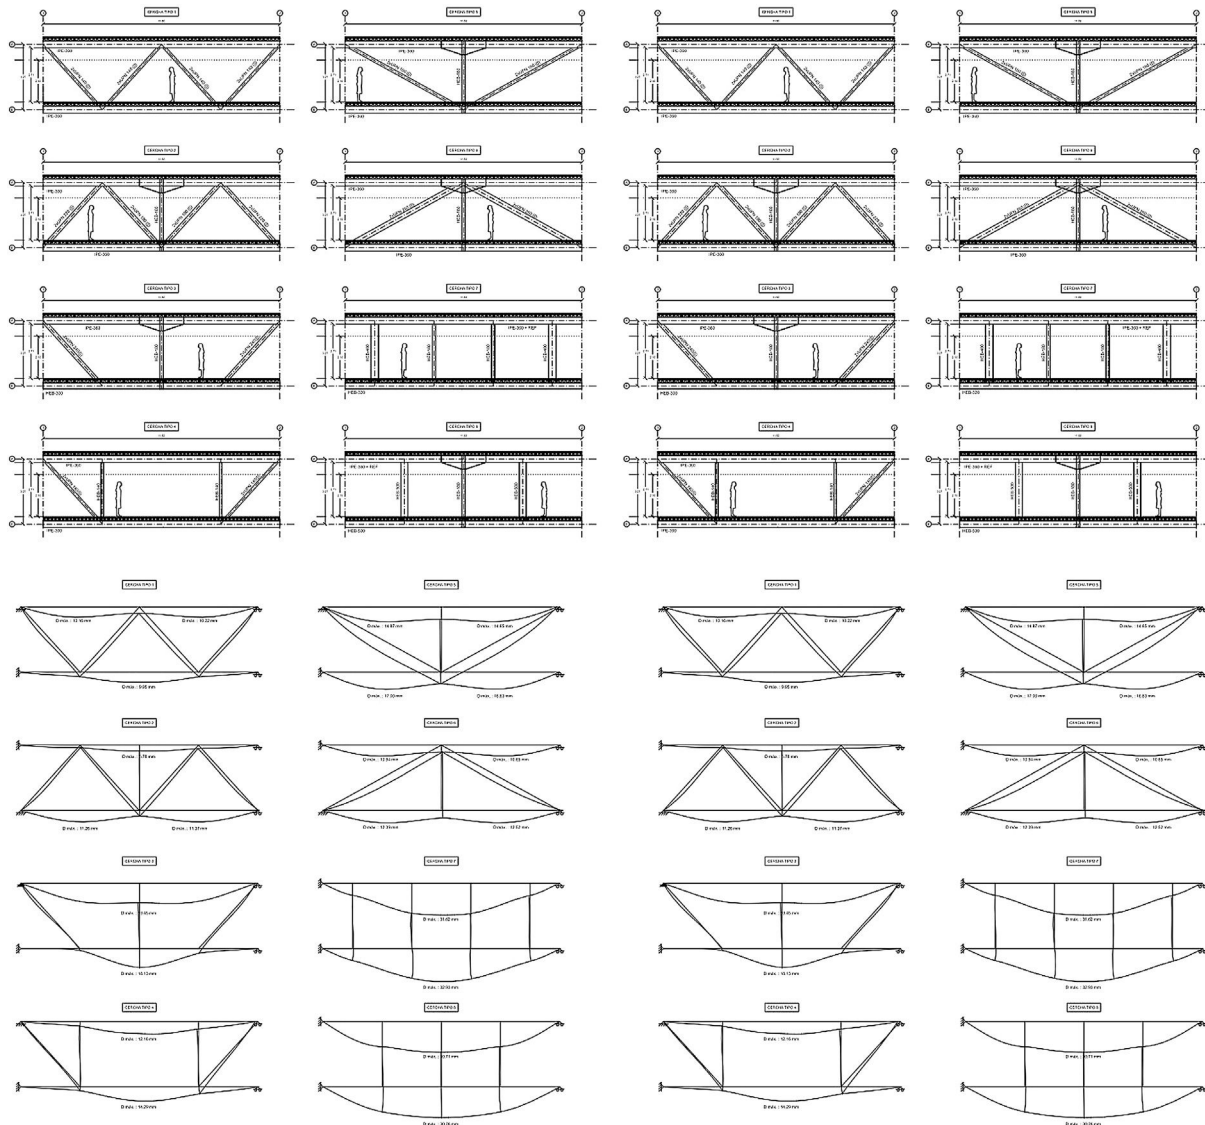
Figure 23. Alternative trusses studied.

In order to adapt the existing building to its new purpose as Google Campus, it was proposed to remove some of the slabs included in the previous refurbishment for the purpose of generating a double-height access area at one end of the building and an auditorium at the opposite end, partially recovering the great space of the original warehouse. As for the auditorium, the intervention involved removing some of the middle columns but keeping the top slab ceiling they supported, so we proposed to keep the beams on that level and those of the bottom level and to connect them so they became top and bottom chords for new trusses generated between the two upper floors (Fig. 23 ).

Several options were studied for arranging the bracings of the new generated trusses. In this study, we took into account a potential subsequent refurbishment in which a new slab floor could be added in the upper zone of the auditorium for the purpose of expanding workspaces at Campus. For this reason, we finally decided to set up several trusses not structurally optimized

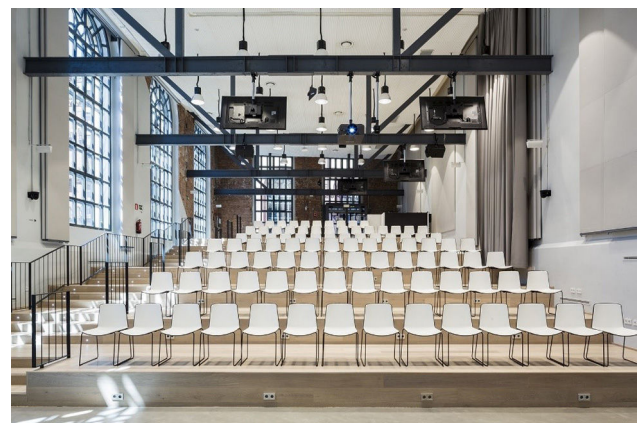
Figure 24. Google Campus Madrid auditorium, featuring the new trusses based on the old beams of the demolished slab floors.

but more compatible with that future purpose by arranging two columns and diagonals in both ends without triangulating the central area (Fig. 24).

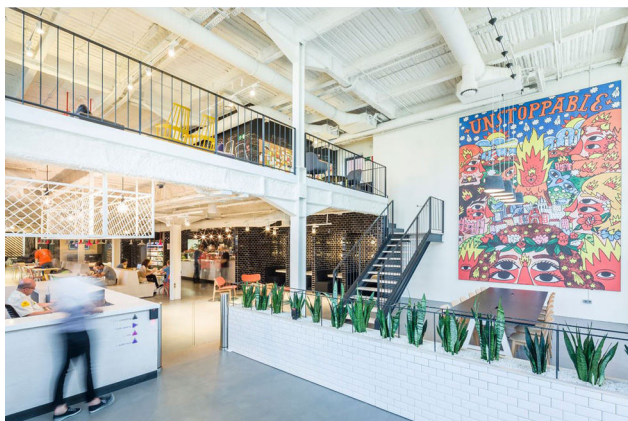
Figure 25. Double-height access area.

In the building refurbishment project, the aim was to recover and enhance architectonic and structural elements of the original building that had been hidden or blurred in the first refurbishment, such as the aforementioned open-plan spaces, the large windows on the façade, or the existing masonry walls. Likewise, the elements already preserved and correctly exposed in the first refurbishment were amended according to the needs, such as the roof trusses, which required new treatment in order to meet the safety requirements in case of fire (Figs. 25 and 26).

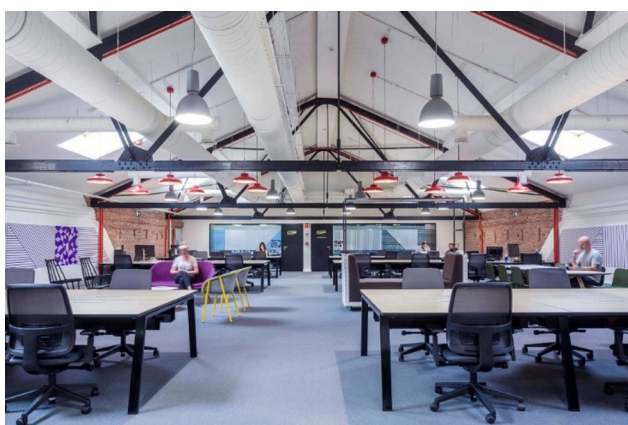
Figure 26. View of the upper floor featuring the original trusses.
