## Enhancement and recovery of the tiles affected by atmospheric pollutants in the Galleries of Punta Begoña, Getxo (Bizkaia)

Punta Begoña Galleries, built in 1918 and located in the municipality of Getxo (Bizkaia, Spain) have a remarkable glazed ceramic decoration, whose current state of conservation presents an advanced level of deterioration. The study of the historical cultural property is framed within a multidisciplinary project, which aims to restore, recover and improve its historical and artistic value. In this sense, the recovery of the ceramic tiles is one of the crucial points, since it involves one of the visually most notorious elements. On the surface of the tiles, different degradations were observed, being the yellowish patina, one of the most significant.

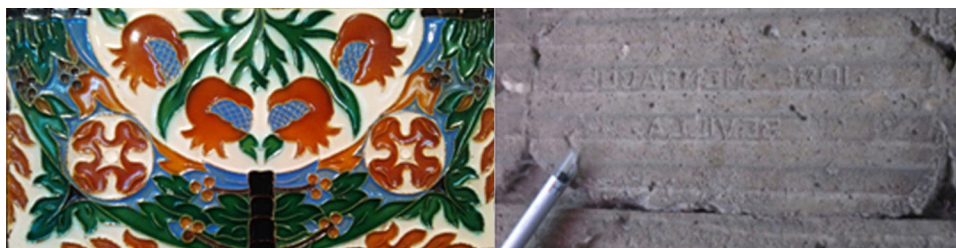
Fig. 1 – Representative tile of Punta Begoña Galleries and imprint on the mortar with the seal of manufacture.

During the interventions in the galleries, it was found in the reverse of a tile the seal of manufacture of the tiles that cover all the galleries. In negative relief, in the mortar of the wall, the imprint of *José Mensaque Sevilla* can be seen. Indeed, the iconography of the tile decorations, has been identified in the Mensaque Rodríguez y Cía catalog, in the Lamina nº3.

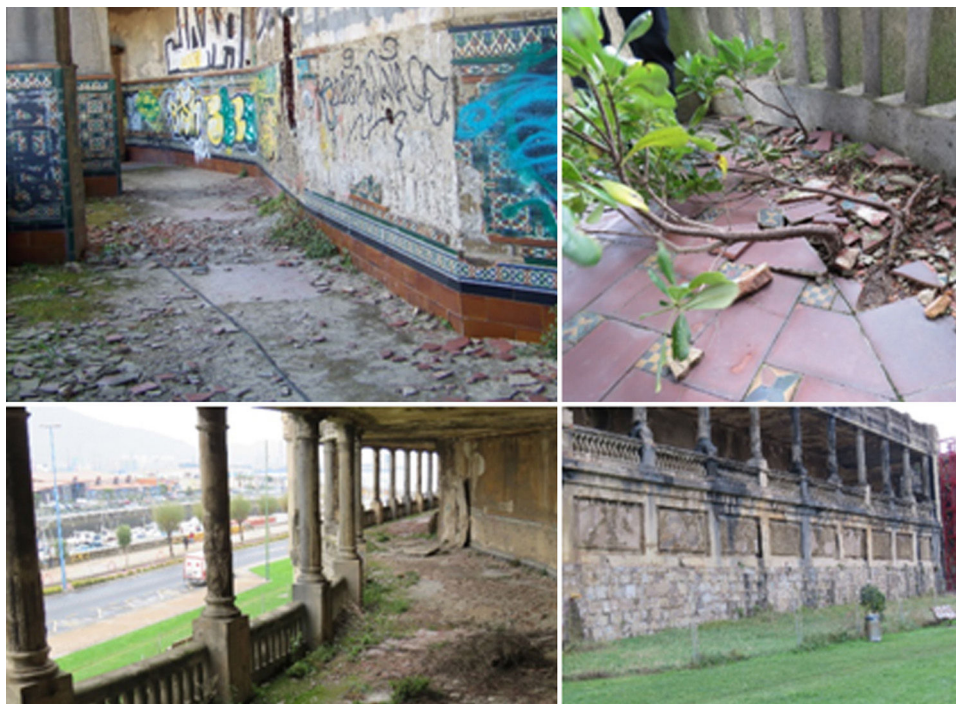
Fig. 2 – Deterioration agents present in Punta Begoña Galleries.

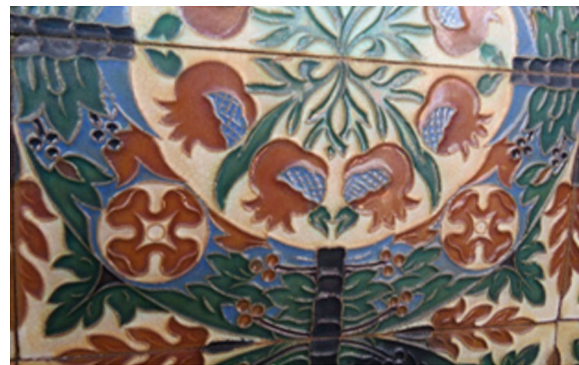
Fig. 3 – Ceramic tiles covered by atmospheric pollutants.

The degradation of the ceramic glazes appears as a yellowish patina that masks the ceramic coatings as seen in Fig. 3. At first glance, it could seem a structural affection of the decaying. However, after the cleaning of other substances accumulated on the pieces, it was verified that this patina could be removed. For this reason, as a parallel work in the mentioned global project, chemical analyses were conducted to determine the origin and composition of this yellowish layer.

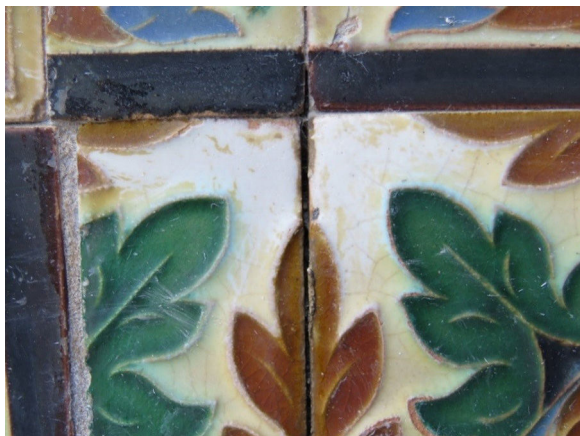
Fig. 6 – Mechanical elimination of atmospheric pollutants.

As an initial step, it was decided to carry out a mechanical cleaning. An inconspicuous area of approximately  $5 \times 5$  cm was chosen. The mechanical cleaning was performed at the tip of a wooden scalpel without the use of any other physical or chemical agent. The observed result could be accepted as partially acceptable with respect to the quality of the cleaning but it could be improved very much because, as can be seen in Fig. 6, there are still rests of the patina covering the ceramic.

In addition, in terms of effectiveness and considering the time required to perform this cleaning operation, the result of the trial was very negative, with more than 10 min needed to clean the chosen area. Anyway, this cleaning test served to confirm that the observed deterioration was a removable patina and not a crust or permanent reaction with the glaze as it could be initially thought. Therefore, it was required to develop a method to proceed with the elimination that combines effectiveness and speed. In this sense, the use of chemical solvents seemed to be the next logical step, and for this, it was necessary to carry out the corresponding resistance tests, prior to the intervention.

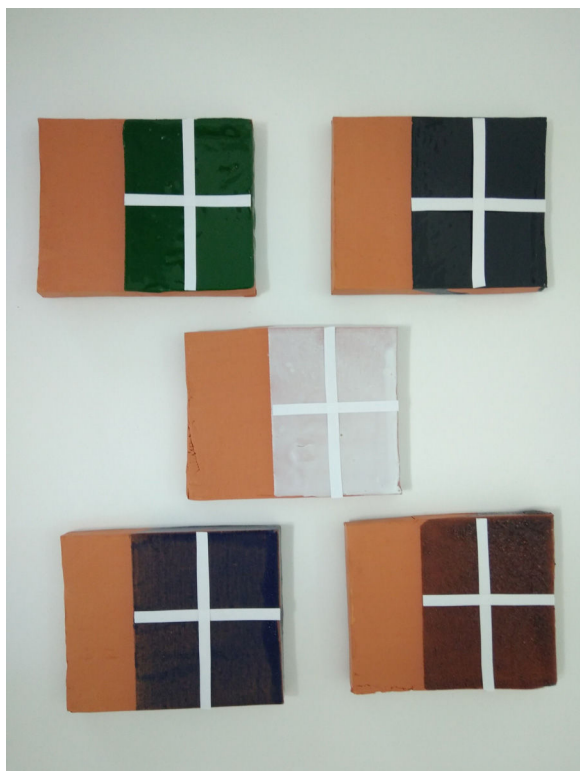
Fig. 7 – Test piece-manufacturing process.

Taking all this into account, the test pieces were divided into four parts, to test the four selected products in each color (Fig. 7). The application was made with a cotton cloth impregnated with the corresponding product in each case, except for the cellulose paper, which was applied in the selected area during an application time of three minutes.

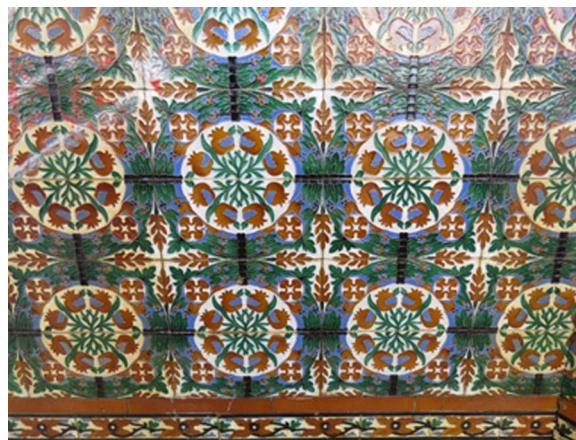
Fig. 8 – Test pieces and methodology applied to clean the atmospheric pollutants.

It is for all this that the proposed cleaning methodology was 3 wt% oxalic acid in water. After deciding the final methodology, a larger test (60 × 60 cm) was carried out to demonstrate the validity of the methodology as shown in Fig. 8.

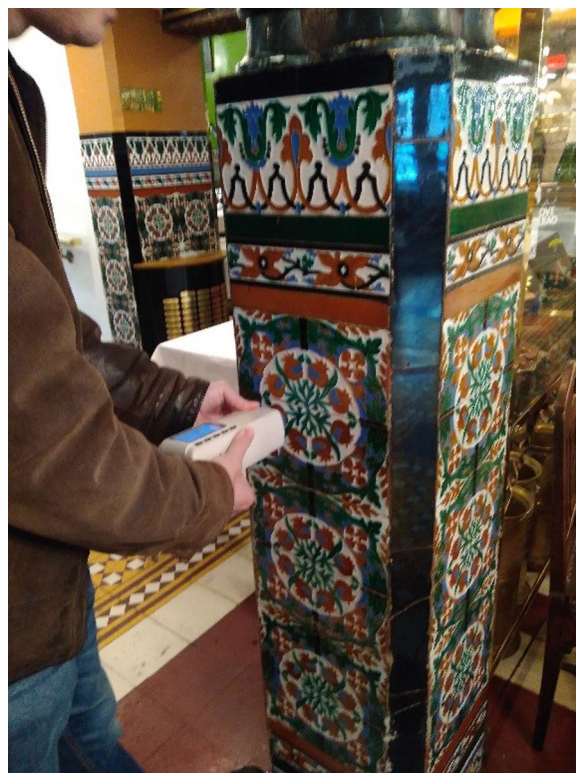
Fig. 9 – Café Iruña interiors in Bilbao.

its walls covered with tiles manufactured in Seville (Fig. 9) such as those found in Punta Begoña Galleries. In this way, the measurements of these whites were considered as the maximum reference values to obtain in the cleaning tests, as external agents did not affect them. Table 5 shows the results obtained, this time, as an average of different measurements in the whole area of the testing and in the same area of reference, allowing multiple analysis of different whites, which generates a result more representative of the efficiency of the global cleaning. In this sense, the obtained white tone is slightly more yellowish than the control white of the Iruña Café, but practically with the same lightness and values of b, being the best results obtained compared with the *in situ* tests. Therefore, the
