Comparative analysis of the wear of titanium/titanium and titanium/zirconia interfaces in implant/abutment assemblies after thermocycling and mechanical loading

Paulo J. Almeida ^{a,*}, Cesar L. Silva ^a, Jorge L. Alves ^b, Filipe S. Silva ^c, Ramiro C. Martins ^d, João Sampaio Fernandes ^a

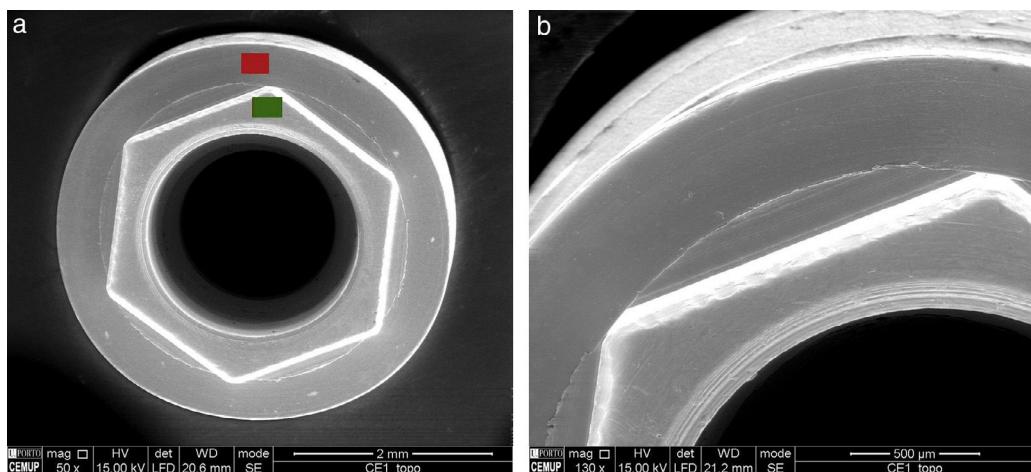
Fig. 1 – SEM photograph of the connection of BNT® S4 implants (a) with 45x and (b) 130x magnification, from an upper view. Red mark – top region, green mark – base region.

We randomly selected six externally hexed (CE) implants from a lot of 20 BNT® S4 implants (Phibo® Dental Solutions, Barcelona, Spain). These implants, composed of pure grade 2 titanium, had a connection platform with 4.0 mm of diameter, a body with 4.2 mm of diameter, and a length of 10 mm (Fig. 1a).

In terms of optical profilometry we selected two reading areas – the top and base regions of the corresponding implant connections (marked respectively with red and green in

Figs. 1a and 4. A white light optical interferometer (Bruker NPFLEX™, Karlsruhe, Germany) was used to measure the surfaces' roughness by 3D profilometry. For each reading in areas of $320 \mu\text{m} \times 240 \mu\text{m}$, a 10 \times magnifying lens with a lateral resolution of $1 \mu\text{m}$ was used. The roughness parameters were established with a two-dimensional Gaussian filter of $80 \mu\text{m}$. The selected roughness parameters were in accordance with the ISO norm 25178-2:2012.³⁵

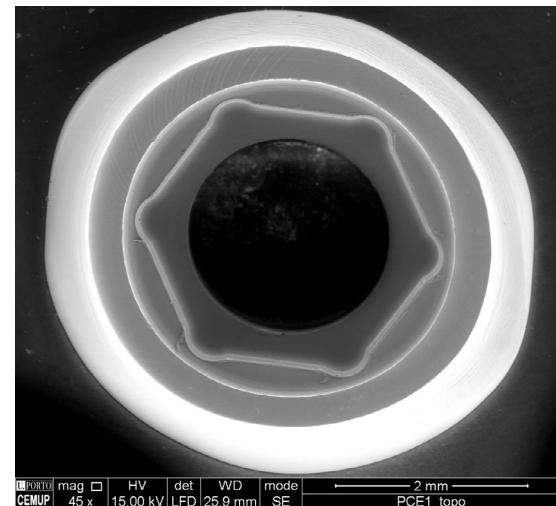
Fig. 2 – SEM photograph of the top of the externally hexed Ti abutment, with 45x magnification.

The titanium abutments (Fig. 2) were obtained using a five-axis milling machine on a block of Ti6Al4V (grade 5 titanium) titanium alloy. This alloy is composed of 90% Ti, 6% aluminum, and 4% vanadium. The zirconia abutments (Fig. 3) were obtained by milling a pre-sintered block of yttria-stabilized tetragonal zirconia polycrystals (3Y-TZP), which was then sintered, according to the ISO 6872:2008 and 13356:2008 standards.³⁴

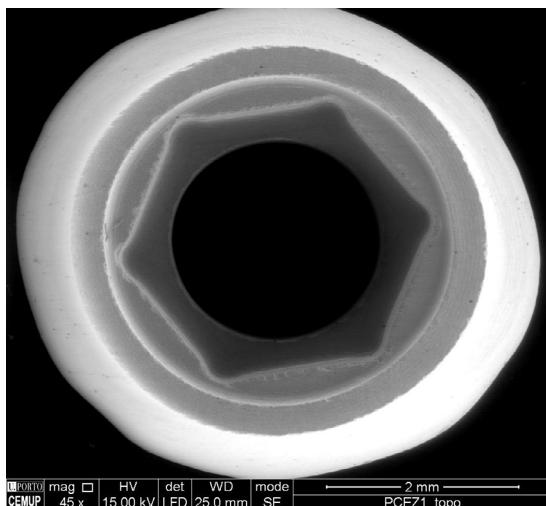
Fig. 3 – SEM photograph of the top of the externally hexed Zr abutment, with 45x magnification.

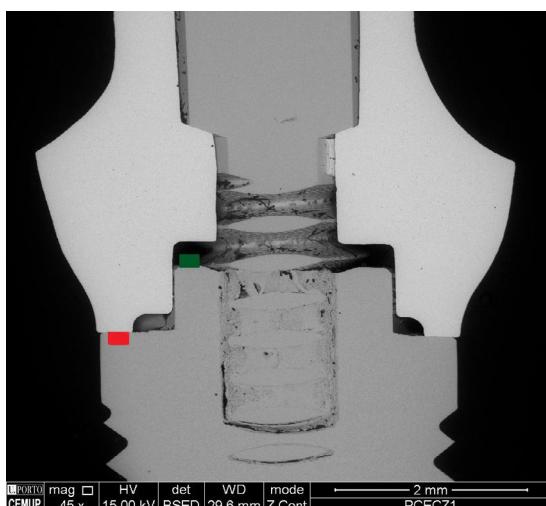
Fig. 4 – SEM photograph of the sagittal plane of the abutment/implant assembly, with 45x magnification, for observing the 3D profilometry reading areas.

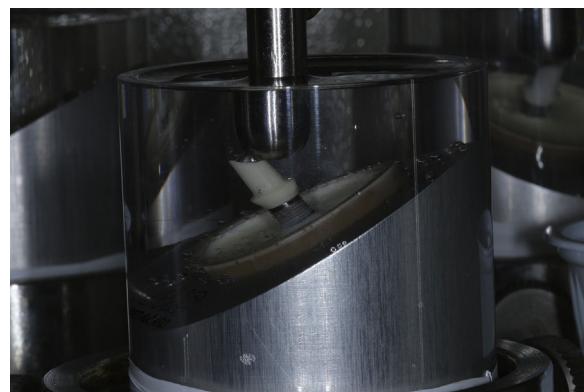
Fig. 5 – Positioning of the samples during the mechanical fatigue simulation. Ra = 193 nm.

The abutment/implant assemblies were placed in a dental surveyor and vertically positioned in polyurethane resin cylinders (F160, Axson, São Paulo, Brazil) at up to 3 mm from the platform, using the mobile rod of the dental surveyor. All samples were subjected to 1.2×10^6 mechanical cycles with loads from 1 to 88 N, with a 4 Hz frequency, in a thermomechanical wear equipment (ERIOS 37000, São Paulo, Brazil), thus corresponding to five years of clinical fatigue (Fig. 5).^{36,37} For that procedure, samples were placed in devices with a 30° angulation in relation to the vertical axis, and loading was applied, using a stainless steel rod with a rounded extremity, in the incisal edge of the palatal surface, in order to mimic the interincisal angle in normal occlusion.³⁸ During this test, the samples were kept in distilled water at 37°C. Instruments and equipment tests were calibrated and suitable for the study.

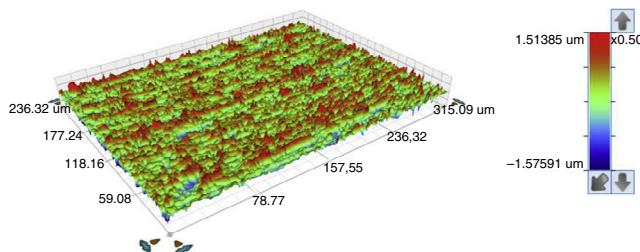
Fig. 6 – 3D profilometry image of the base region of the external connection implant (CE), at the initial state, in an area of measurement of 320 μm × 240 μm. Ra = 205 nm.

The three-dimensional representation of the surface topography is demonstrated in Figs. 6 and 7, where the legend's color code explains the roughness levels: green for zero roughness, blue for valleys and depressions, and red for peaks.

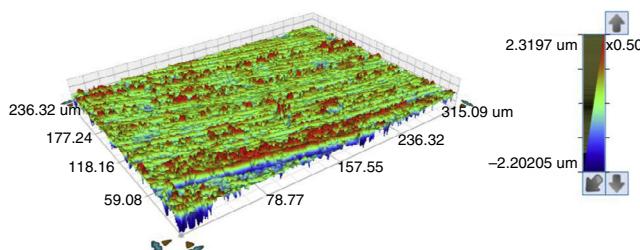
Fig. 7 – 3D profilometry image of the base region of the external connection implant (CE4), after TCML, in an area of measurement of 320 μm × 240 μm.

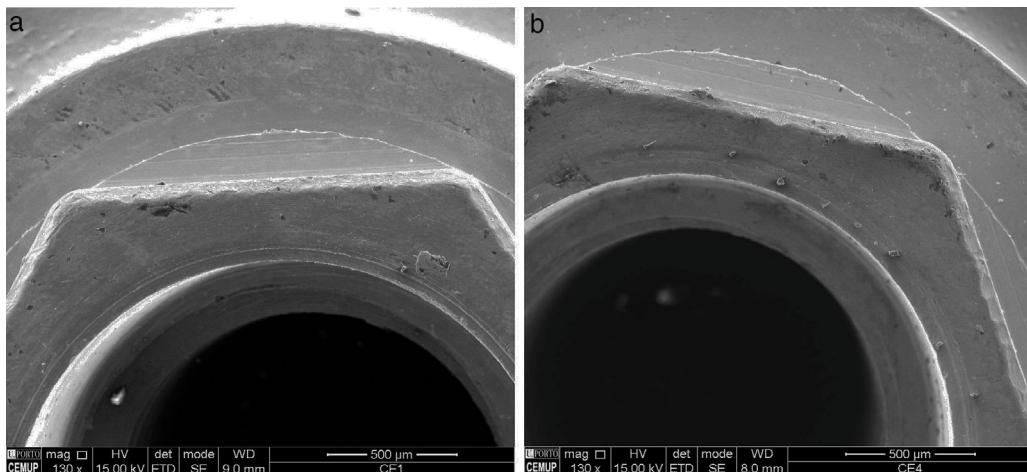
Fig. 8 – SEM image of the top of the implant connections to a titanium abutment (a) and a zirconia abutment (b), after TCML, with 130 \times and 500 \times magnification.

The analysis of the SEM images with 130x and 500x magnification revealed a slight wear at the vertices of the implant's external hex when connected to zirconia abutments (Ti/Zr) after TCML (Fig. 8). Also, small zirconia particles were detected in those same locations (represented by "Z2" in Fig. 9) in

of the hexes of the implants connected to zirconia abutments (Fig. 8b, blue arrow), and zirconia particles resulting from the abutment's disintegration (Fig. 9). Ceramic materials are harder and more wear resistant but as do not deform plastically reveal low fracture toughness. This situation was not observed in the analysis of the hexes of implants connected to titanium abutments (Fig. 8a). The wear at the vertices of the hex is caused by a 30° tangential force applied to the abutment/implant assemblies, leading to a moment that reaches its maximum in that area. Some particles (Ti, Zr, and Al particles) resulting from wear were detected in the seating platforms. Zirconia abutments were subjected to XRD analysis that revealed absence of crystallographic phase changes, from what there were no signs of aging.⁵

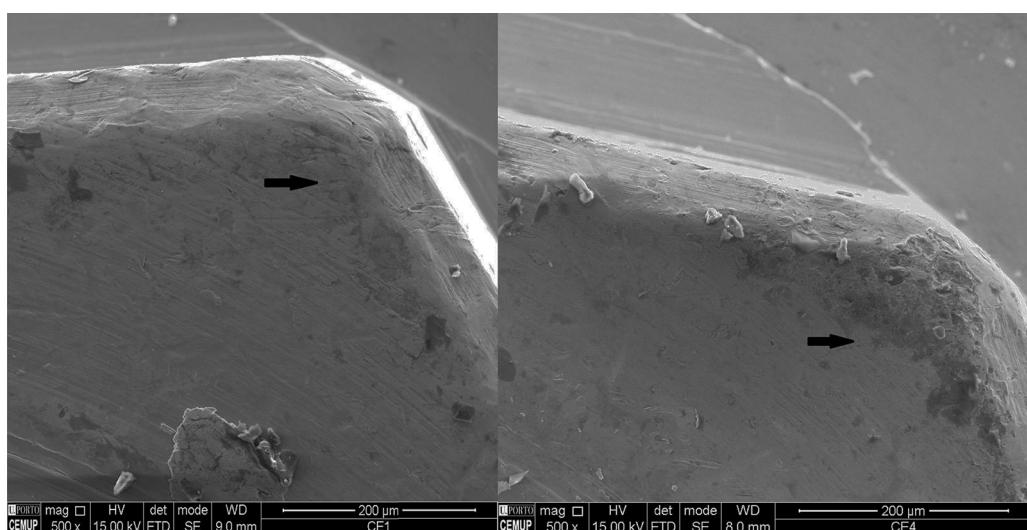
Fig. 9 – SEM image of the vertex of the implant's external hex in the Ti/Zr assembly after TCML, with 3000 \times magnification, showing zirconia particles (Z2).

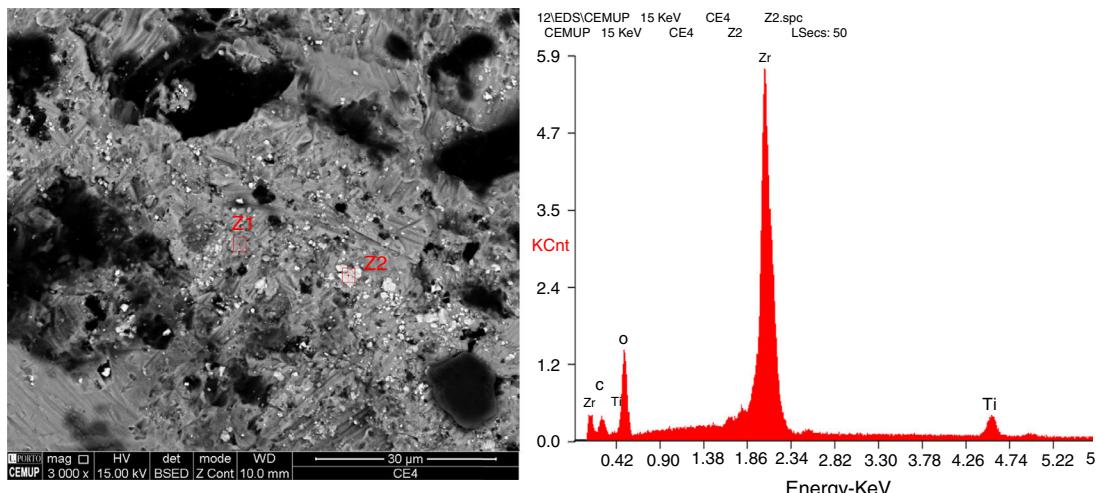
Fig. 10 – EDS on the region marked as Z2, with a spectrum peak corresponding to Zr.

the SEM images with 3000x of magnification, and their presence was confirmed by energy dispersive X-ray spectroscopy (EDS) – Fig. 10.
