# Robustness: The quality Ribera missed in 1905

## *Robustez estructural: la calidad que echó de menos Ribera en 1905*

Eduardo Díaz-Pavón Cuaresma<sup>a,\*</sup>, Javier León González<sup>b</sup>, Jorge Ley Urzáiz<sup>a</sup>

This is also the case of the collapse of the roof of the Third Reservoir of Canal de Isabel II in Madrid in April 1905 [4]. This is an excellent example of a projected structure lacking analysis of robustness. 30 people died and 6 people were injured in this accident, which is one of the most serious to happen in building in Spain and yet is still little known. The following section will look at this case to analyze its cause and subsequently reflect on the subject of robustness in existing structures.

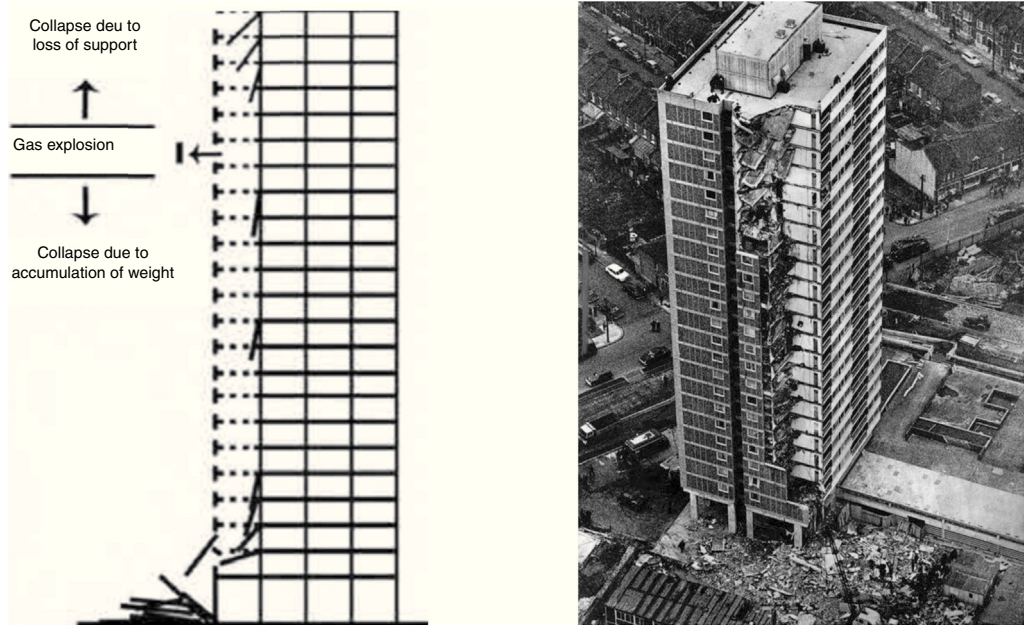
Figure 1. Partial collapse of the Ronan Point tower on May 16th 1968. London [2].

1968 (Fig. 1) was the cause of the incorporation of the concept of progressive failure into the British codes (and hence into the rest of the regulations), along with the consideration of accidental or unusual actions [1]. The accident happened in the early hours of the morning of the 16th May 1968, when one of the neighbours was about to prepare a cup of tea. On lighting a match, the stove gave off an explosion of gas which then blew out the windows and the external walls of the living room. As a result the whole corner of the building collapsed like a line of dominos [2]. The external wall enclosure was made up of floor to ceiling pre-fabricated reinforced concrete panels set on concrete floor slabs. So, when one of these walls failed it consequently provoked the collapse of all those above it, and with the accumulation of weight, the corresponding destruction of those below. These employed the Larsen-Nielsen system which filled the joints between the walls and the slab with mortar but without any reinforcement whatsoever. Therefore, on suffering a horizontal action, as with the explosion, its resistance capacity was highly reduced and therefore failed. But more important than the magnitude of this horizontal action is that it caused the progressive collapse as a result of a partial failure.

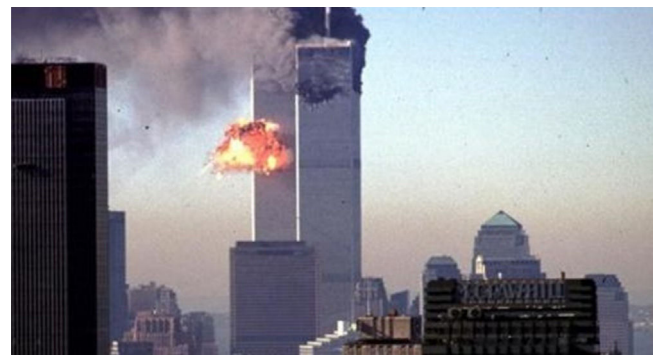
More recently we could witness the total collapse of the World Trade Center towers in New York as the result of the impact of two BOEING 767s (Fig. 2). The structural damage produced by the impact was aggravated by the fire from the planes' fuel which caused the area to lose its capacity to withstand the load born upon it, and on collapsing provoked the progressive failure of all the floors. As a result of these attacks, a manual titled the FEMA-426/BIPS-06 [3] was issued in the United States to mitigate the effects of terrorist attacks on buildings. At the same time, it served as a wake-up call to consider robustness in structures, and nowadays a number of teams are working on this matter.

Figure 2. Attacks 11th September 2001. New York.

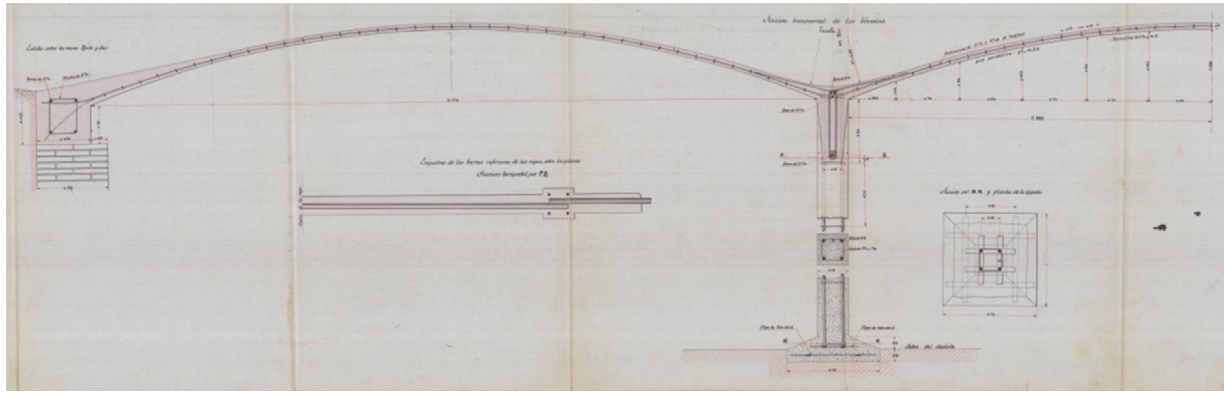
The success of the construction of this reservoir served him to propose the same typology for the new reservoir in Madrid. This time the geometry would be slightly riskier (Fig. 5) with vaults spanning 6 m and 5 cm thick (span/thickness = 1/20). The columns were 8 m tall and 25 cm square on the sides (slenderness 1/32). Though the slenderness of the vaults was endorsed by the aforementioned Monier system, the slenderness of the columns was far greater than current standards; Ribera simply justified this by offering his prior positive experience in the San Sebastián Ceramic Factory which had employed even slenderer columns and with greater loads.

Figure 5. Transversal section of the roof proposed by Ribera.

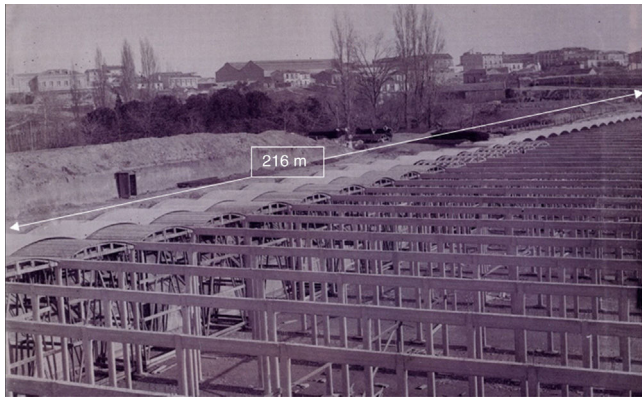
This configuration is repeated over 21 spans of beams and 36 spans of vaults until covering the area of 216 m × 85 m in each chamber (339 m × 216 m in total) (Fig. 6).

Figure 6. Construction of the Third Reservoir of Canal de Isabel II. Madrid, 1905.

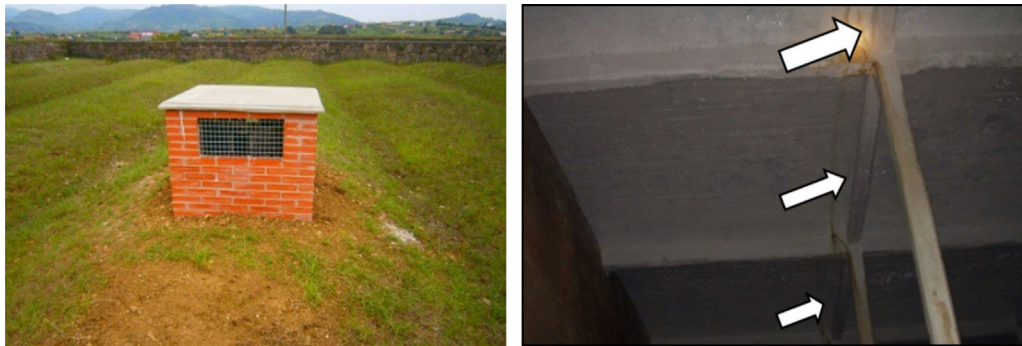
Figure 16. The Roces III Reservoir (Gijón) today (Courtesy EMA, Gijón).

results of the “fears” that something similar could happen in the Gijón Reservoir (even though this was not as sensitive as the one in Madrid due to its geometry), provided the roof with a number of transversal beams which did not exist in the original Project (and thus cannot be seen in the photographs of its construction) (Fig. 16).

In conclusion, he converted a very sensitive roof in relation to any local failure into a very robust structure along with additional mechanisms to withstand the loads so that if an element failed (for example by local failure of a vault), the loads could still be born through other resistant mechanisms. Similar procedures may be found in other roofs with alike typologies, whether originally conceived as this or as measures of reinforcement. Two examples may be seen in Fig. 17.

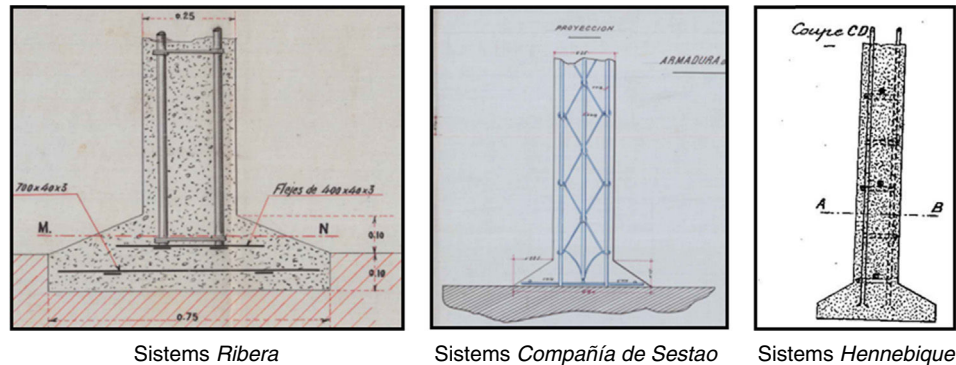
As a final example, and getting back to the Third Reservoir, we can return to the footing detail of the columns on the foundations. The configuration shown in Fig. 14 is not exclusive to Ribera, being equivalent of that used, for example, by Hennebique or which may be found in some of the first publications on reinforced concrete of the time (Fig. 20).

Figure 20. Different types of detail of column footing on foundation.
