Application of digital image processing to mortar crack analysis

Image analysis techniques can be used to detect and interpret the degradation processes that a material undergoes and to help identify the causes and mechanisms of degradation. Structures and morphological changes are also analysed to establish hypotheses about physical changes. Together with complementary analytical techniques, chemical and mineralogical changes can be evaluated.

The methodological process consists of a sequential simplification of the initial micrograph: segmentation of the image, cleaning and isolation of the crack from associated elements, and crack skeletonisation. This method allows the previous image to be processed, thus successfully isolating the microcracks. It is also valid for their quantification.

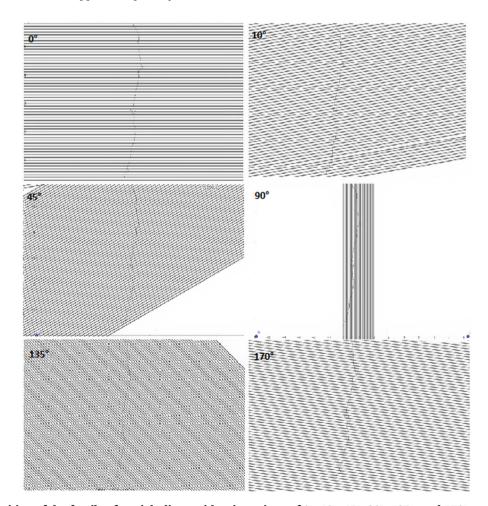
Fig. 6 – Superposition of the family of straight lines with orientations of 0°, 10°, 45°, 90°, 135°, and 170° on the skeleton of microcrack 1.

The family of straight lines was oriented with angles of 0° , 10° , 45° , 90° , 135° and 170° (Fig. 6). Each intersection was marked with dots to facilitate their counting (Fig. 7).

not perfectly oriented in one direction, but it was not isotropic. The dominant direction was given by the angle of the smallest number of intersections, in this case 90° , with the vertical direction dominating in the fracture. In the example studied, it was possible to approximate the dominant direction of the deviations from the main direction, which would be given by the angle of the second smallest value in the number of intersections $(0-30^{\circ})$. These data can be presented graphically using a polar plot (Fig. 8) in which the intersection results are plotted as a function of angle.
