boletín de la sociedad española de cerámica y vidrio xxx (2023) xxx-xxx

Original

Application of digital image processing to mortar crack analysis

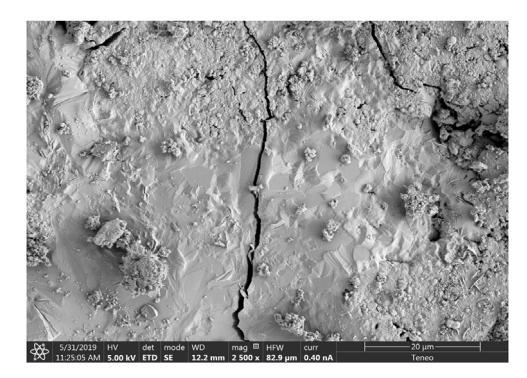
Fig. 1 - Micrograph of cracking in mortar matrix.

The samples studied were mortars manufactured for this study and subjected to a heating process at 800° to elicit the cracking of the material. The images were obtained by scanning electron microscopy in a FEI TENEO microscope and one of them was selected to be analysed. The samples were prepared by gold sputtering. The data scale referred in the original SEM micrograph is the same for all microcrack images.

To process the starting micrograph (Fig. 1), it was converted into binary (black and white) images through a segmentation process (Fig. 2). The segmentation established a threshold where the upper values were set to white and the lower values were set to black, thus converting the greyscale image into a black and white image. A manual black and white threshold was applied followed by visual inspection of the final result to ensure minimal loss of information. In addition, image binarisation algorithms could also be used to convert the greyscale image into a binary image containing only black and white information [1].

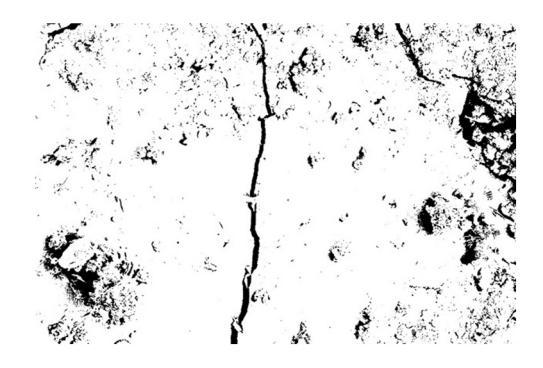
Fig. 2 – Binary image after applying the black and white thresholding.

Fig. 2 shows not only the microcrack but also pores, created by air bubbles, and aggregate particles. The conversion of the binary crack image into crack skeletons was required to measure both crack lengths [25] and to subsequently process it as a mathematical object to remove from the image everything that was not a crack and everything that was not interesting to measure. A three-step process was therefore carried out [14].

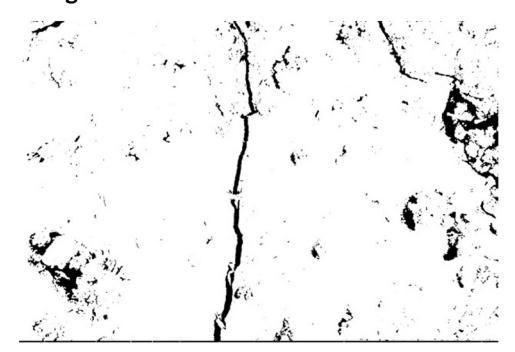
Fig. 3 - Appearance of the fissure after image cleaning.

On the other hand, the aim of the image cleaning was to remove isolated and insignificant particles that did not belong to the crack. First, an erosion process was carried out using a structuring element of appropriate size, followed by an expansion step using a structuring element of the same size. This was repeated iteratively until the image no longer changed (Fig. 3).

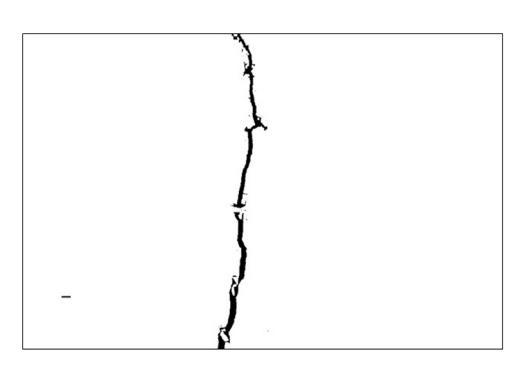
The shape analysis consisted of removing isolated particles and other non-crack objects by considering the shape of the cracks. Cracks were distinguished as individual objects with an elongated shape, most of which were interconnected in a network. A criterion based on the ratio of the area of an object to its containing circumference was used to obtain an image in which only the crack remained (Fig. 4).

Fig. 4 - Appearance of the crack after the shape analysis.

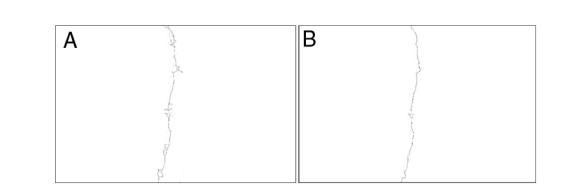
As with skeletal reduction or skeletonisation, the skeleton function was used to study and characterise the cracks in the material after their detection [26]. The final objective of the treatment was to obtain fine lines representing the cracks (Fig. 5A) [5]. The automated skeletonisation command was first used, and then the skeleton was *pruned* to remove *parasitic branches*. The pruning automatically detected the nodes where the crack branched, and branches smaller than the defined size were removed, so a pruning of size *n* attempted to remove branches smaller than *n* pixels that emerged from the skeleton (Fig. 5B). As a result, parasitic branches were usually smaller in

Fig. 5 – Appearance of the crack after automatic skeletonisation (A) and after the pruning of parasitic branches (B).

length than the average width of the original crack, so *n* could be used as a threshold for pruning [7].

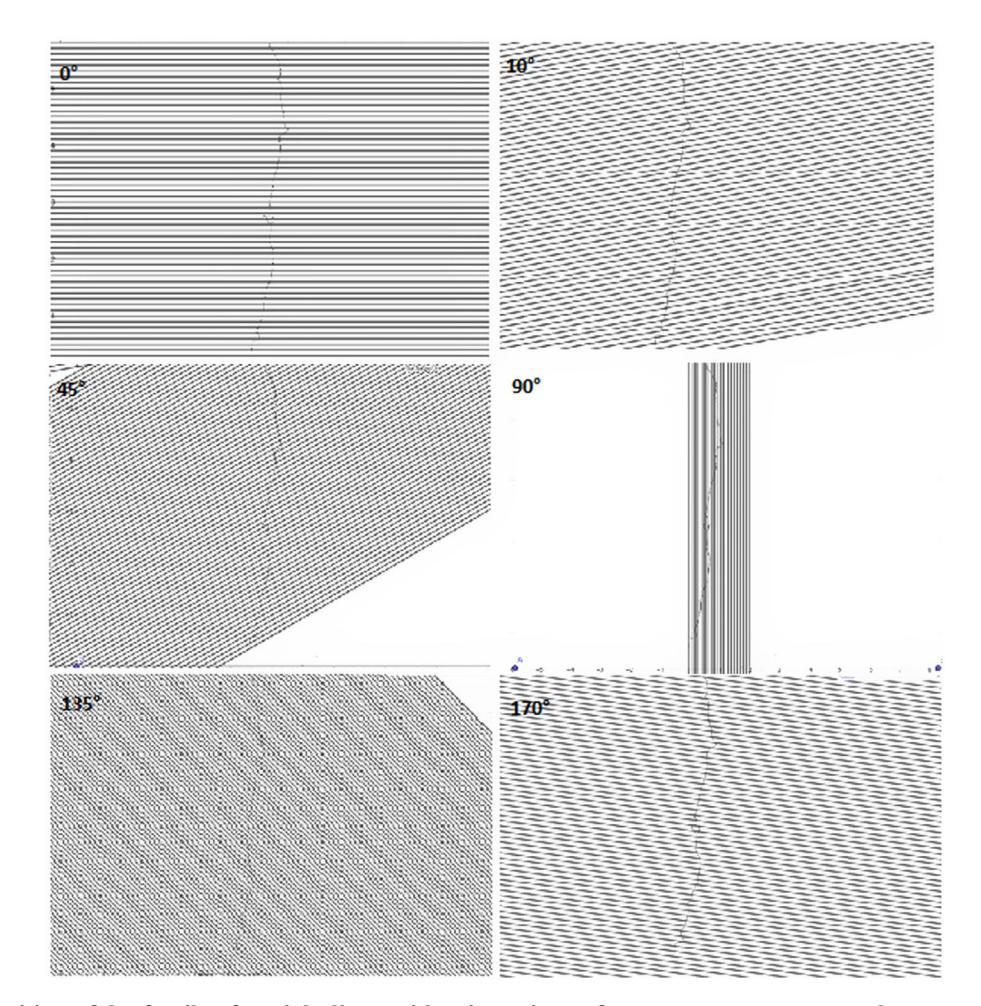
The family of straight lines was oriented with angles of 0° , 10° , 45° , 90° , 135° and 170° (Fig. 6). Each intersection was marked with dots to facilitate their counting (Fig. 7).

Fig. 6 – Superposition of the family of straight lines with orientations of 0°, 10°, 45°, 90°, 135°, and 170° on the skeleton of microcrack 1.

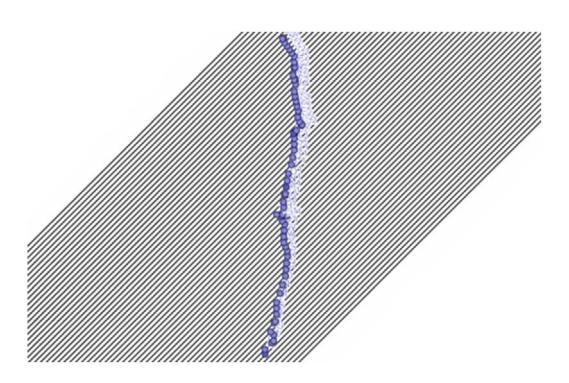
Fig. 7 – Example of the point layout for 45° intersection counting.

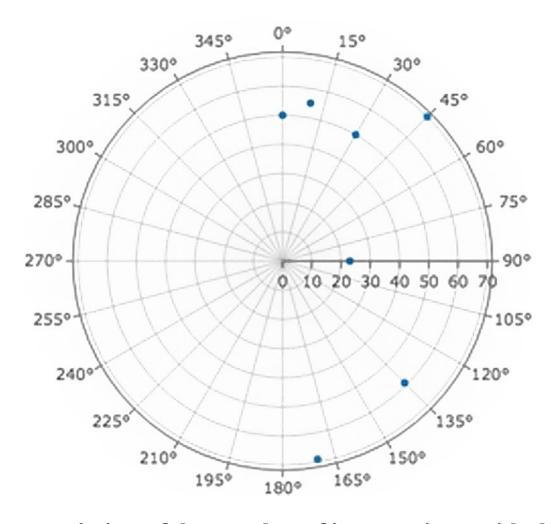
Fig. 8 – Variation of the number of intersections with the angle of the straight lines.

not perfectly oriented in one direction, but it was not isotropic. The dominant direction was given by the angle of the smallest number of intersections, in this case 90° , with the vertical direction dominating in the fracture. In the example studied, it was possible to approximate the dominant direction of the deviations from the main direction, which would be given by the angle of the second smallest value in the number of intersections (0–30°). These data can be presented graphically using a polar plot (Fig. 8) in which the intersection results are plotted as a function of angle.

$N_{min}(90^{\circ}) = 23 \, mm^{-1}; N_{max}(45^{\circ}) = 70 \, mm^{-1}$

$\omega = 0.56$
