# Revista Colombiana de Anestesiología

### Case report

## Intraoperative transesophageal echocardiography to evaluate a Gerbode defect<sup>☆</sup>

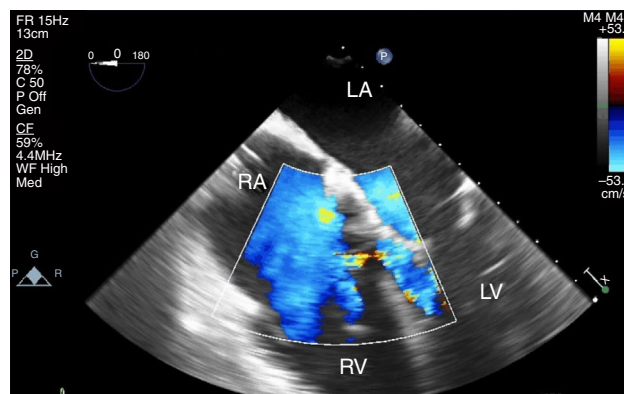
**Fig. 1 – Mid esophageal four chamber view. CFD shows communication between the LV and the RA.**  
Source: Authors.

Due to the severity of the paravalvular leaks and AI, the patient was scheduled for redo AVR. Intraoperative pre-cardiopulmonary bypass transesophageal echocardiography (TEE) confirmed severe AI and dilated LV. Further interrogation confirmed blood flow between the LV and the RA, consistent with an acquired Gerbode-type ventricular septal defect (VSD), with flow present in both systole and diastole. No 2-D or color flow doppler (CFD) evidence of a communication between the aortic root and the RA was seen (Figs. 1-6).

Our patient likely developed the Gerbode defect secondary to the surgical intervention he had to replace his aortic valve and/or the enterococci endocarditis. The Gerbode defect was best seen in the mid-esophageal four chamber view, the right ventricular inflow-outflow tract view and deep trans-gastric view (Figs. 1-6). Flow was seen through the defect during both systole and diastole excluding the possibility of tricuspid regurgitation artifact. CFD and 3-D echocardiography were used for anatomic characterization of the defect.

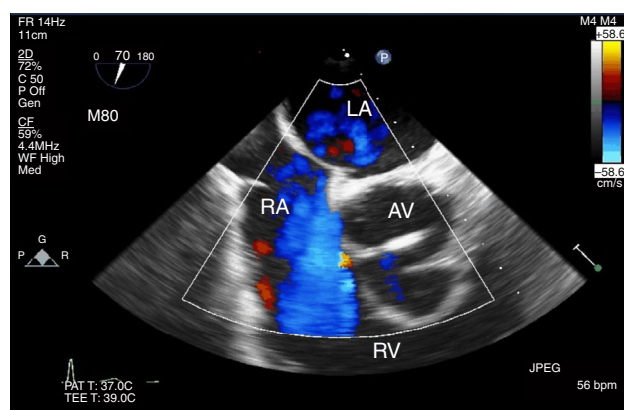
**Fig. 2 – Mid esophageal RV inflow-outflow tract view. CFD shows flow just below the aortic valve to the right atrium.**  
Source: Authors.

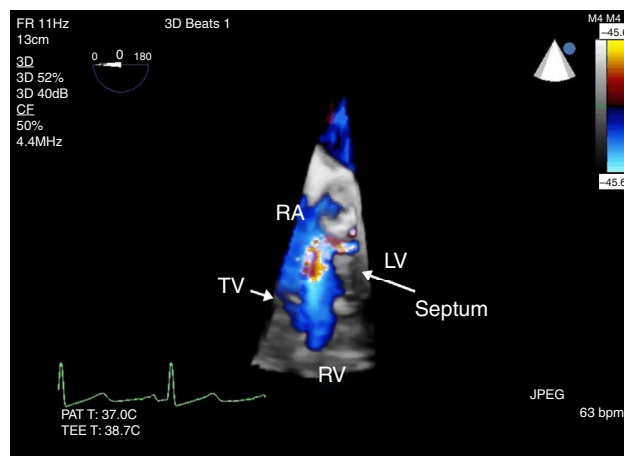
**Fig. 3 – 3-D CFD across the defect seen from Fig. 1, ME four chamber view. Flow is seen above the level of the tricuspid valve (TV) with a defect in the septum.**  
Source: Authors.

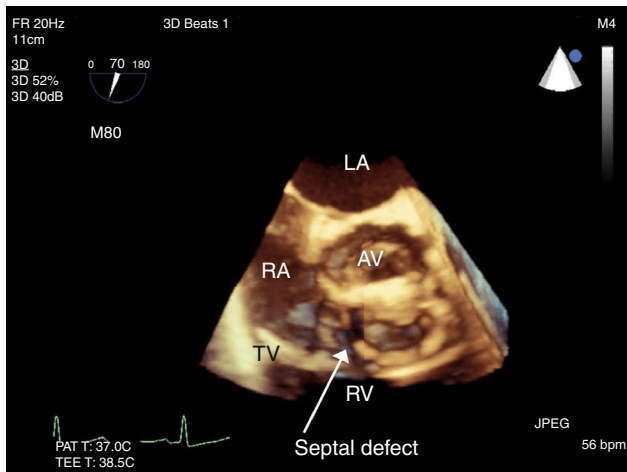
**Fig. 4 – 3-D image showing the septal defect above the tricuspid valve seen from Fig. 2, ME RV inflow-outflow tract view.**

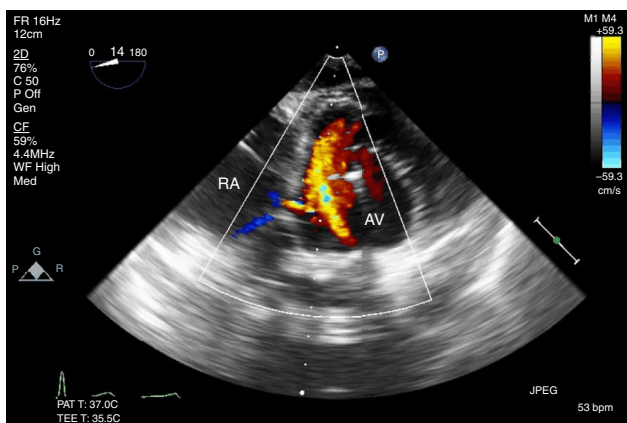
**Fig. 5 – Deep trans-gastric view showing aortic valve and right atrium. CFD showing flow through the septal defect.**

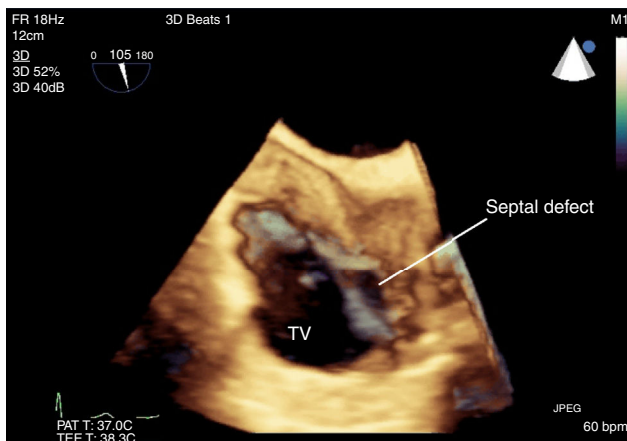
**Fig. 6 – 3-D ME bicaval view. Septal defect is visualized just above the tricuspid valve.**

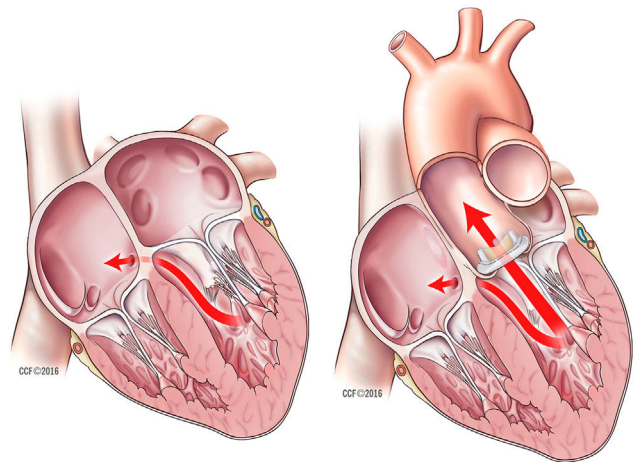
**Fig. 7 – Gerbode defect. Reproduced with permission.**

The Gerbode defect is a rare form of shunt from the LV to RA due to either congenital or acquired causes. The defect occurs in the membranous portion of the inter-ventricular septum above the level of the tricuspid valve (Fig. 7). The acquired causes include complications of invasive cardiac procedures like aortic valve replacements, endocarditis, trauma or myocardial infarction. The pathogenesis of an intra-cardiac fistula with endocarditis is due to translocation of the infection from the valve to adjacent myocardium.<sup>1-3</sup> Real-time TEE is the mainstay for diagnosis and 3-D echocardiography can provide anatomic characterization of the shunt. The TEE views that show the Gerbode defect best are those that can exam-
