BRIEF REPORT

Aortic root rupture and acquired intracardiac shunt after transcatheter aortic valve implantation[☆]

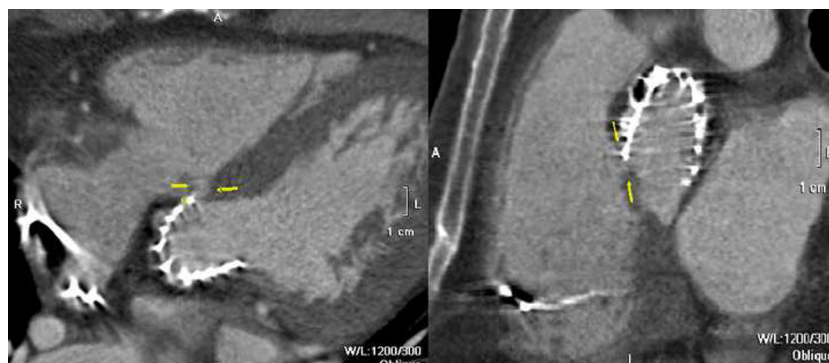
Figure 1 Reconstruction of oblique MPR multidetector computed tomography images showing fine annular communication between the aortic root and the right ventricle, just below the right coronary sinus (yellow arrow).

MDCT confirmed the presence of an annular communication between the aortic root and the right ventricle, just below the coronary sinus (Fig. 1), together with a subannular defect in the membranous interventricular septum (intracardiac shunt) (Fig. 2). The subannular defect measured 5 mm, and the communication between the aortic root and the right ventricle was 10 mm wide and 7 mm deep.

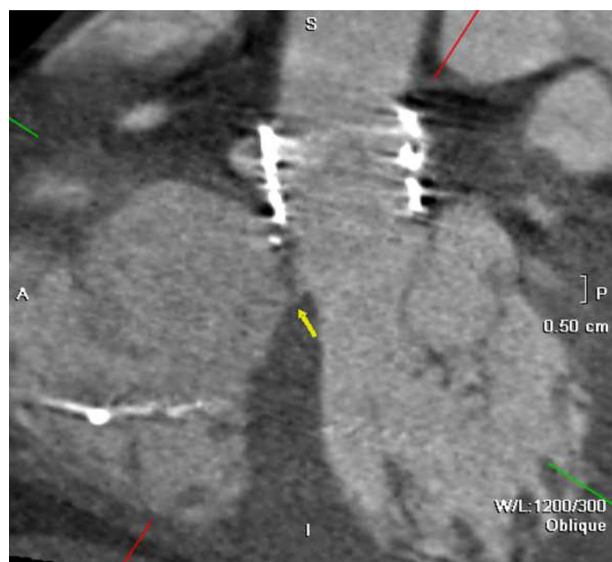
Figure 2 Reconstruction of oblique MPR multidetector computed tomography images showing the presence of a subannular defect in the interventricular septum.
