Spanish Journal of Legal Medicine

FORENSIC MEDICINE IN IMAGES

Iatrogenic gas embolism☆

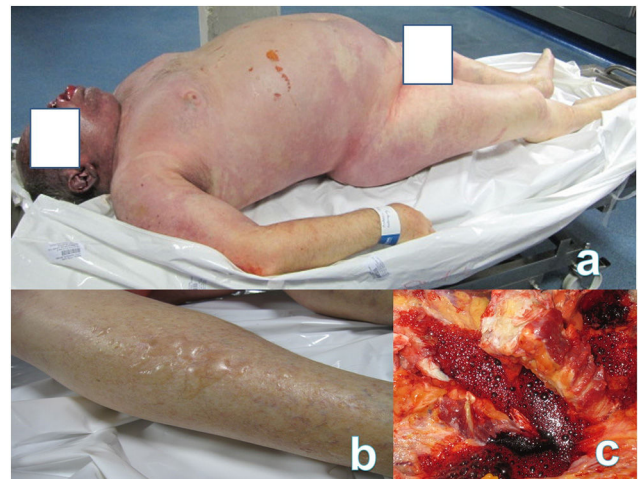
During the external examination of the autopsy, we found massive emphysema with blisters on the lower limbs, and internal examination found multiple bubbles in the vascular tree (Fig. 1). Histopathological study revealed a poorly differentiated epidermoid carcinoma, ganglion metastasis, and visually empty pulmonary vessels resulting from the gaseous emphysema.

Fig. 1 (a) Emphysematous body. (b) Blisters on the lower limbs. (c) Bubbles in the vascular bed of the open subclavian artery.

An 81 year-old male with a history of arterial hypertension, type 2 diabetes mellitus, and left pneumectomy visited the emergency department due to dyspnoea on exertion and orthopnoea without previous respiratory symptoms. Computed tomography showed a right pulmonary hilar mass compatible with neoplasia. Treatment commenced with antibiotics, laxatives, benzodiazepines, and nebulizers. 1.30 h after starting treatment with nebulized 250 µg/2 ml ipratropium bromide, the patient was found on the floor with emphysema and ventricular fibrillation, and he died immediately. When the endovenous catheters were removed, one of the lines from the nebulizer compressor was found to be directly connected to the serum, and this originated the gaseous embolism.

the compressor to the serum, as the fit is not good and a certain degree of leakage occurs. It was therefore impossible to calculate the exact amount of gas that had been injected.
