Effect of tooth whitening on dental restorative materials

Objective: To evaluate the effects of tooth whitening with 10% carbamide peroxide on the surface ultramorphology of three dental restorative materials.

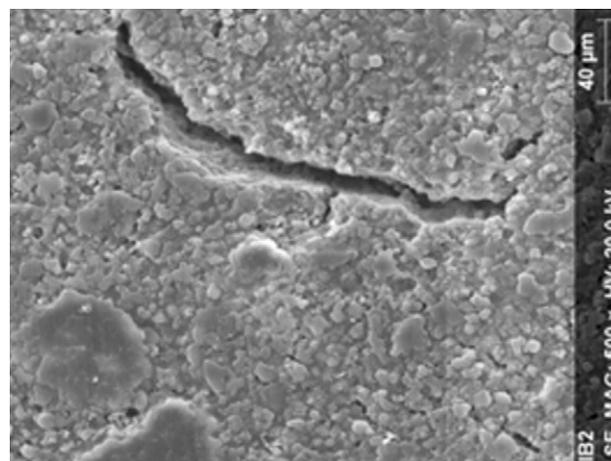
Fig. 1 – SEM micrograph of reinforced zinc oxide-eugenol cement specimen exposed to 10% carbamide peroxide (500×).

The microscopic analysis of the reinforced zinc oxide-eugenol cement specimens, exposed to CP, revealed an irregular surface, with numerous and relatively large cracks and pores (Fig. 1). Specimens from the control group showed a smooth surface, and although some cracks and pores were visible, these were few and small in size (Fig. 2).

The results obtained with the reinforced zinc oxide-eugenol cement specimens are consistent with those found by Rotstein et al., where the 10% CP and HP solutions were applied for 7 days. Until date, that was the only article published assessing the effect of whitening on this material, using SEM.⁴

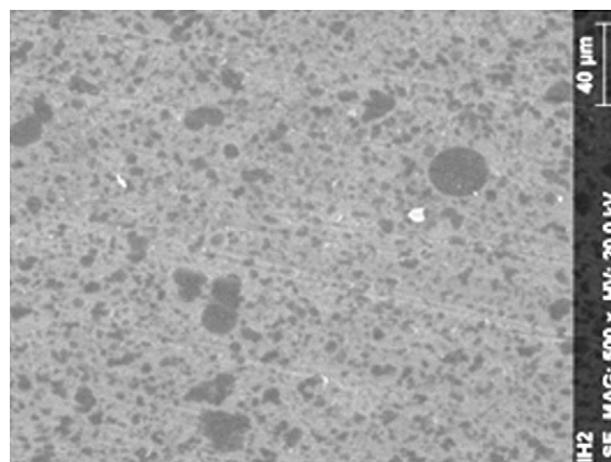
Fig. 2 – SEM micrograph of reinforced zinc oxide-eugenol cement specimen of control group (500×).

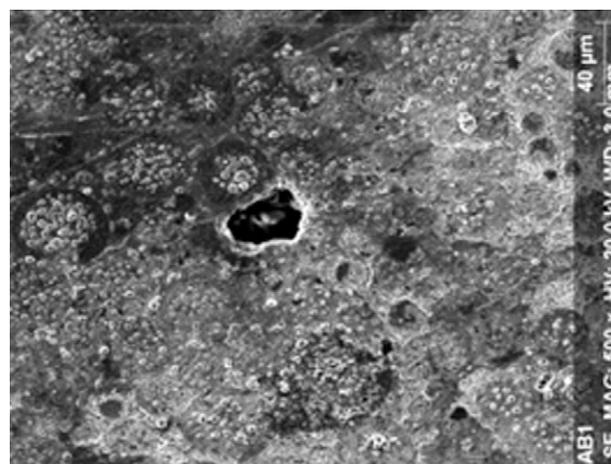
Fig. 3 – SEM micrograph of amalgam specimen exposed to 10% carbamide peroxide (500×).

Regarding the amalgam groups, the specimens subjected to the whitening procedure had an uneven surface ultramorphology with pores and some scattered cracks (Fig. 3). In the control group, the micrographs revealed a regular surface, with evidence of the spherical nature of the tested amalgam (Fig. 4).

Regarding amalgam, the differences observed between specimens of the whitening and the control groups are supported by the study of Rotstein et al.⁵ On that study, the authors established an association between the surface degradation induced by the whitening agent and, a decrease on the levels of tin and copper, or increased levels of mercury

and silver. Usually with amalgam, the anticorrosion effect is related with the presence of tin and copper. The values found by those authors allowed the conclusion that the decrease in the level of these constituents was caused by the oxidative effect of the whitening agent. In the present study, the surface degradation observed may be due to the action of reactive oxygen molecules caused by the decomposition of CP. These molecules may have reduced the copper-tin phase, leaving the surface material unprotected, and leading to a dissolution of the mercury phase, the largest of any amalgam, which resulted on the existence of cracks and pores, in contrast to the specimens exposed only to distilled water.

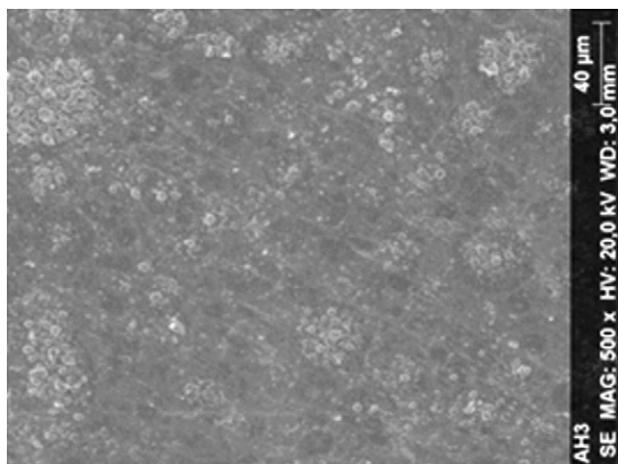
Fig. 4 – SEM micrograph of amalgam specimen of control group (500×).

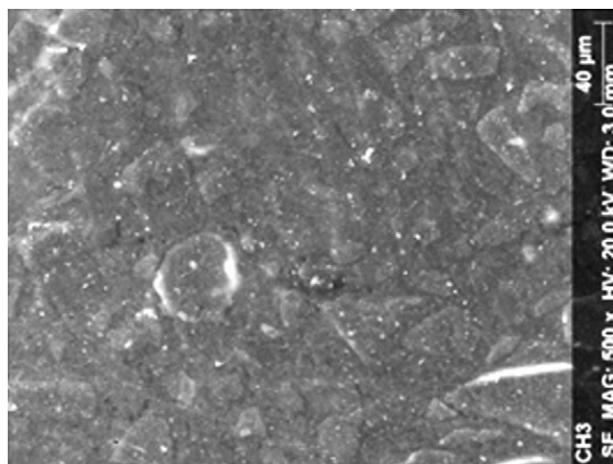
Fig. 6 – SEM micrograph of composite specimen of control group (500×).

Composite specimens exposed to CP revealed on the microscopic analysis multiple cracks and an increase in surface porosity (Fig. 5). Specimens of the control protocol presented a regular surface morphology, without the existence of cracks (Fig. 6).

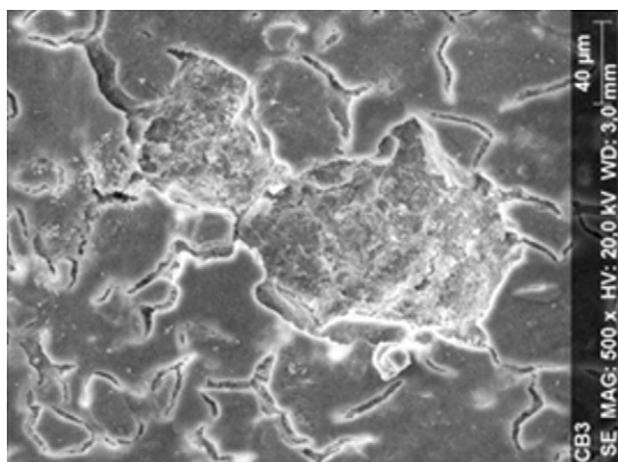
Fig. 5 – SEM micrograph of composite specimen exposed to 10% carbamide peroxide (500×).

Composites are more prone to chemical changes, compared to metal or ceramic restorations, due to their organic matrix.¹⁷ HP has the ability to degrade the matrix polymers of the resin composites.¹⁷ It has been suggested that HP and highly energetic radicals may have an effect on the filler-resin interface and cause a separation of the matrix and the filler, which results in crack propagation and increased surface roughness.³

According to Polydorou et al.,¹⁵ the lower content of inorganic filler of some materials may be the cause of their greater susceptibility to changes during the whitening procedure, and differences in surface roughness are more likely to be expected to occur with composites with higher content of resin and less of inorganic filler. In the present study, the surface changes were displayed as an increased occurrence of porosity and cracks. This seems to be related to the relatively low content of inorganic filler of the nanohybrid composite used, which was
